DDAS Accident Report

Report date: 19/05/2006	Accident number: 391
Accident time: 12:00	Accident Date: 10/05/2002
Where it occurred: OES 3, MF 147, Bayt Yahun	Country: Lebanon
Primary cause: Unavoidable (?)	Secondary cause: Inadequate equipment (?)
Class: Excavation accident	Date of main report: 16/05/2002
ID original source: Bol: No001/2002, MJF	Name of source: MACC SL
Organisation: Name removed	
Mine/device: No.4 Israel AP blast / frag	Ground condition: agricultural (abandoned) grass/grazing area
Date record created: 22/02/2004	Date last modified: 23/03/2004
No of victims: 1	No of documents: 2

REPORT FOR ACCIDENT INVESTIGATION BOARD OF INQUIRY – No001/2002

MINE Accident that occurred in OES 3 on 10 May 2002 in which [Demining group] Team Leader [name excised] was injured.

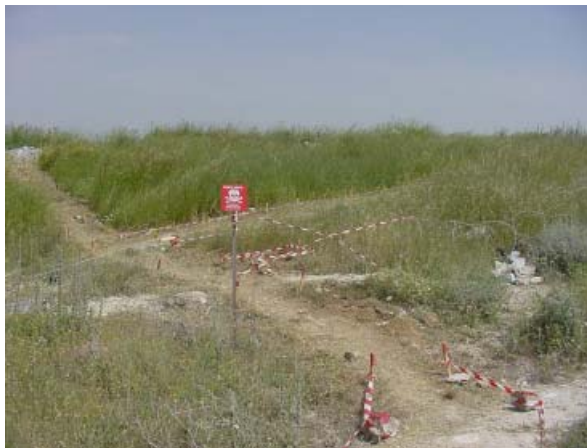
VIEW OF THE BASE AND ACCIDENT LANES, LOOKING EAST FROM A SAFE AREA

[The “accident lane” spurs off the “base lane” to the right.]

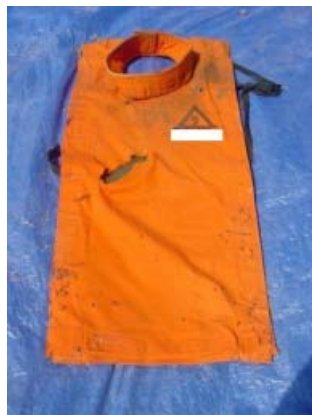
TEAM LEADER [the Victim]'s PROTECTIVE JACKET

27. At the time of the accident, Manual Team Leader [the Victim] was wearing his protective apron and protective visor. On inspection of the protective apron, the following points were noted:

- The outer cover was ripped in several places.
- There was blast debris concentrated at the top left hand side.
- There was part primary fragmentation penetration of the Kevlar lining.
- There was no complete penetration of the Kevlar lining.

[Pictures of the inside of the apron (beneath the cotton cover) have been omitted. The apron is made using ballistic aramid, not Kevlar, and has a NATO STANAG V50 rating of 380 m/s.

The insertion of a small 5mm polycarbonate chest plate does not raise the protection to the required levels.]

- All explanatory sketches and maps require a signature and date.
- The protective jacket and visor maintained their integrity following the uncontrolled detonation of an Israeli No4 AP mine at a distance of approximately 80 cms.

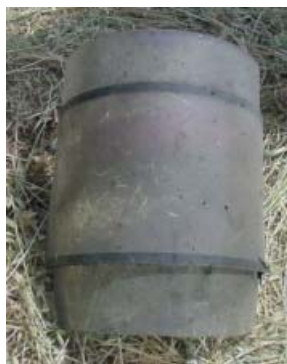
THE PROTECTIVE VISOR

28. On inspection of the protective visor, the following points were noted:

- A large proportion of the blast effects were concentrated on the outer face of the visor.
- There was part fragmentation penetration of the polycarbonate visor.
- There was no complete fragmentation penetration of the polycarbonate visor.

Blast effects across the face of the visor.

[The investigators interpreted the burned-out fragments pitting the visor face and scratch-guard as partial penetrations. No fragments penetrated fully.]

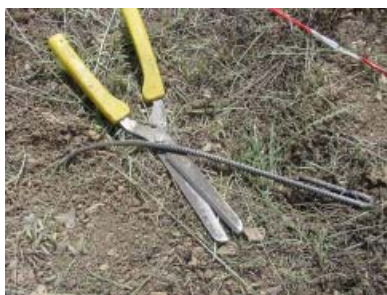
DEMINE PROBE USED BY TEAM LEADER

29. At the time of the accident, the only item of equipment that was being used was a standard [Demining group] metallic probe, one of 4 x different probes types currently used by [Demining group]. On inspection of the probe, the following points were noted:

- The end of the probe had bowed at an angle of approximately 110 degrees from the normal horizontal position.
- The tip of the probe had melted and become deformed.
- The probe was located at a distance of 2.15m from the seat of detonation.

[The picture above shows the bent probe with a burnt tip. It is made "candytwist" reinforcing bar and has been criticised in other theatres where this demining group works.]

- The end of the probe had bowed at an angle of approximately 110 degrees from the normal horizontal position due to the pressure generated during the detonation of the high explosive fill.
- The tip of the probe had melted and become deformed due to the extremely high temperatures generated on the detonation of the high explosive fill.

- In order for the tip of the probe to melt and deform, it must have been intimate contact with the mine prior to detonation.
- If the probing action had been taking place above the mine, the probe would have been located at a distance greater than 2.15m away [sic?]; the bowing and deformation of the probe would also not have been as substantial.
- The omni-directional blast effects, sub-surface levels are far higher and more concentrated than those on or near the surface.
- It was the downward movement of the probe, which caused the traumatic amputation of [the victim]'s thumb.

The primary cause is listed as "Unavoidable" because it seems likely that the victim was working properly in line with approved SOPs when the accident occurred. The secondary cause is listed as "Inadequate equipment" because the prodder being used is an unsuitable tool. Approximately 12mm in diameter, it is a length of cheap reinforcing bar intended for use in concrete buildings. The wide diameter and "candytwist" make it hard to use effectively as a "feeling" probe. The lack of a proper handle (a bent loop serves this purpose) is probably what caused the victim's thumb to be torn off. This demining group have been criticised for this prodder in other theatres.

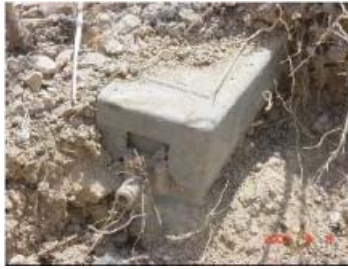
ISRAELI No.4 AP BLAST MINE

33. There have been instances reported where foreign bodies have embedded themselves in between the recess in the striker mechanism and the slotted striker retaining plate, therefore allowing the partial downward release of the plate. The spring-loaded striker is now therefore only being held by the foreign body.

34. Accumulated pressure over a period of time (especially in heavy soil conditions), can also slowly release the slotted striker retaining plate. This therefore reduces the direct pressure required to activate the mine.

38. The BOI concludes that the most likely explanation why there was an uncontrolled detonation is that the base of the Israeli No4 AP mine was moved in an upward direction by the demining probe. This would have caused the release of the slotted striker retaining plate through counter-lever action, therefore allowing the spring-loaded striker to move forward and impinge on the detonator.

40. As explained previously (Para 33 & 34), it must also be noted that there is the possibility that the slotted striker retaining plate may not have been securely fitted around the spring-loaded striker through either foreign bodies being present or accumulated downward pressures over a period of time.
