DDAS Accident Report

Report date: 27/03/2004	Accident number: 405
Accident time: 08:20	Accident Date: 19/08/2001
Where it occurred: Bregana Dubrovnik Highway, Near Urije. Licko-Senjaska, Licki Osic	Country: Croatia
Primary cause: Field control inadequacy (?)	Secondary cause: Management/control inadequacy (?)
Class: Missed-mine accident	Date of main report: 17/09/2001
ID original source: NO/ML	Name of source: CROMAC
Organisation: Name removed	
Mine/device: PMA-2 AP blast	Ground condition: leaf litter metal scrap route (verge) woodland (bush)
Date record created: 24/03/2004	Date last modified: 27/03/2004
No of victims: 1	No of documents: 1

Accident Report on a Project demining a “Section of the Highway Bregana Dubrovnik (Section III B2, Licki Osik – Sv. Rok) – area of Urije – phase 2” involving the company [Demining group]. The clearance project identification code was: LSLO-SB-ICH-198-07-00

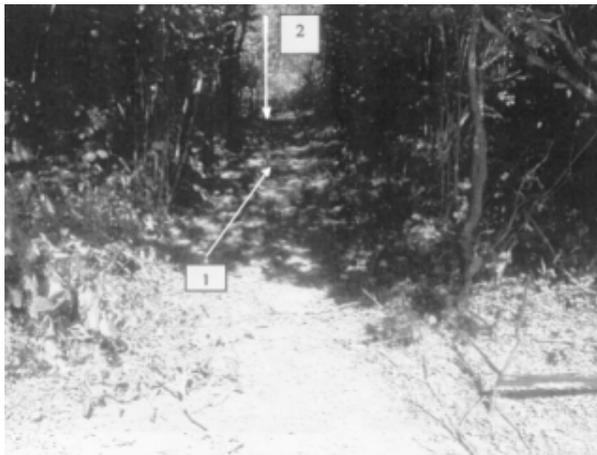
[The picture shows the lane approaching the accident site with the position of the PMR-2A mines indicated.]
