# DDAS Accident Report

<b>Report date:</b> 06/07/2005	<b>Accident number:</b> 414
<b>Accident time:</b> 10:04	<b>Accident Date:</b> 24/08/2004
<b>Where it occurred:</b> Erlalai, Nr Punnalaikadduwan, Valikamam South, Jaffna	<b>Country:</b> Sri Lanka
<b>Primary cause:</b> Field control inadequacy (?)	<b>Secondary cause:</b> Inadequate training (?)
<b>Class:</b> Excavation accident	<b>Date of main report:</b> 25/08/2004
<b>ID original source:</b> SP	<b>Name of source:</b> SP
<b>Organisation:</b> Name removed	
<b>Mine/device:</b> P4Mk2 P4Mk1 AP blast	<b>Ground condition:</b> hidden root mat rocks/stones woodland
<b>Date record created:</b> 06/07/2005	<b>Date last modified:</b> 06/07/2005
<b>No of victims:</b> 1	<b>No of documents:</b> 1

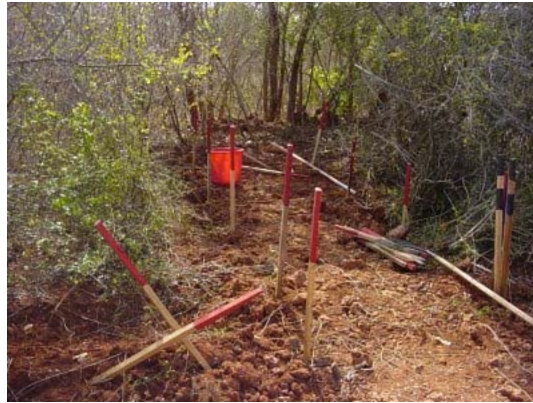
“Description: Accident spot terrain type is rocky red clay with heavy vegetation.”

[The picture above shows the accident lane.]

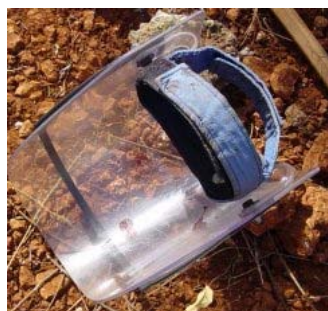
[The picture above shows the Victim's visor with blood spots on the inside.]

“Paramedic comes to spot one minute later, gives first aid, notices a small bleeding wound in deminer’s left cheek and three small bruises in the left arm. Small stone has hit the deminer in the face, entering between fragmentation vest collar (body protection) and bottom of visor (head protection).

- 1) Wearing protective equipment in a correct manner, leaving not open entrance between body protection collar and head protection visor.
- 2) Using heavy rake clearance method between two roots, where rake cannot be pulled freely, makes little sense. Instead, prodder is to be used always when a spot is a difficult one to check. After that cutting the roots with pruner, before advancing to heavy rake method.

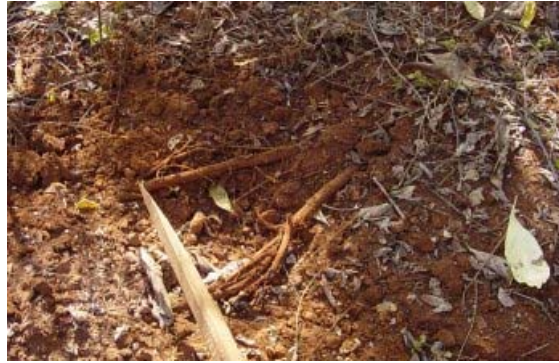
“Experienced deminer **sets up an antipersonnel mine with his heavy rake**. There are two one inch thick bush roots lying horizontally in depth of four centimetres, twenty five centimetres from each other. Antipersonnel mine was situated between the roots. Instead of prodding the spot between the roots, deminer continued raking with heavy rake.

[The picture above shows the roots in the blast crater with the broken handle of the rake pointing inwards.]
