DDAS Accident Report

Report date: 08/07/2005	Accident number: 415
Accident time: 08:50	Accident Date: 27/08/2004
Where it occurred: Punnalaikadduwan village, Valikamam South, Jaffna Province	Country: Sri Lanka
Primary cause: Inadequate equipment (?)	Secondary cause: Management/control inadequacy (?)
Class: Excavation accident	Date of main report: 28/08/2004
ID original source: JA-132 / LK-225 SP	Name of source: SP
Organisation: Name removed	
Mine/device: P4Mk2 P4Mk1 AP blast	Ground condition: bushes/scrub hard
Date record created: 08/07/2005	Date last modified: 08/07/2005
No of victims: 1	No of documents: 2

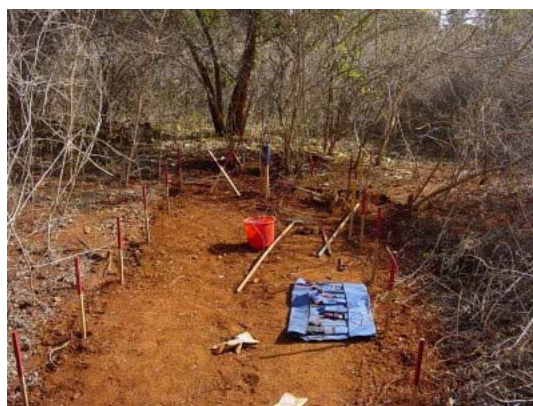
“Incident spot terrain is hard, red clay type soil with vegetation. Soil is softened before raking by moisturizing it with plenty of water. Antipersonnel mine was situated in a clear clay spot without rocks, heavy vegetation nor other disturbing objects around.

[The picture above shows the accident lane.]

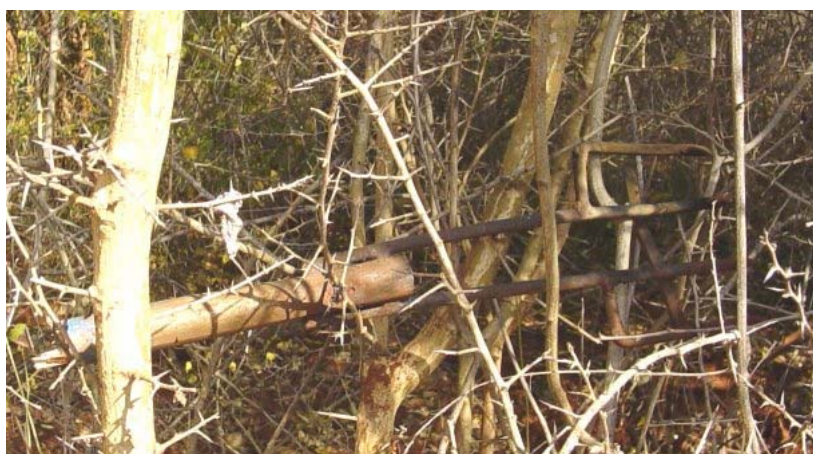
“Experienced deminer uses his rake slowly and in a correct manner according to SOP. Suddenly he sets off an antipersonnel mine with his heavy rake. Heavy rake breaks into two pieces in the blast. Deminer remains in perfect health and doesn't have bruises nor other minor injuries.

[The picture above shows the broken rake in bushes to the side of the lane. The rake was not the approved tool, having four tines.]

The primary cause of this accident is listed as *“Inadequate equipment”* because the rake used was not approved for use internally by the group and had been previously shown to detonate mines in use. [The four-tine rake had been the cause of much bad publicity for the rake excavation method.]

The “inadequate equipment” listed under “Notes” refers to the four-tine rake.

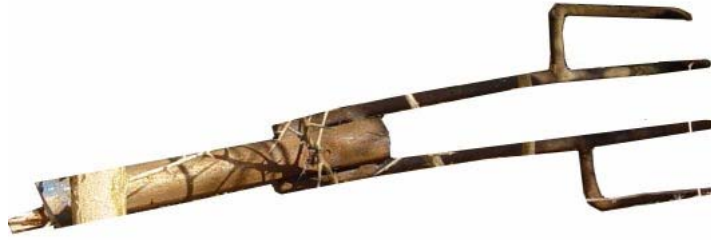
[The undergrowth has been erased in this picture to reveal the rake tines.]
