DDAS Accident Report

Report date: 19/05/2006	Accident number: 418
Accident time: 15:30	Accident Date: 08/10/2003
Where it occurred: Malvil Village, Pallai region, Kilinochi District	Country: Sri Lanka
Primary cause: Inadequate survey (?)	Secondary cause: Inadequate equipment (?)
Class: Missed-mine accident	Date of main report: 10/10/2003
ID original source: TG/RS	Name of source: LA
Organisation: Name removed	
Mine/device: M15 AT blast	Ground condition: hard route (verge)
Date record created: 21/07/2005	Date last modified: 21/07/2005
No of victims: 3	No of documents: 2

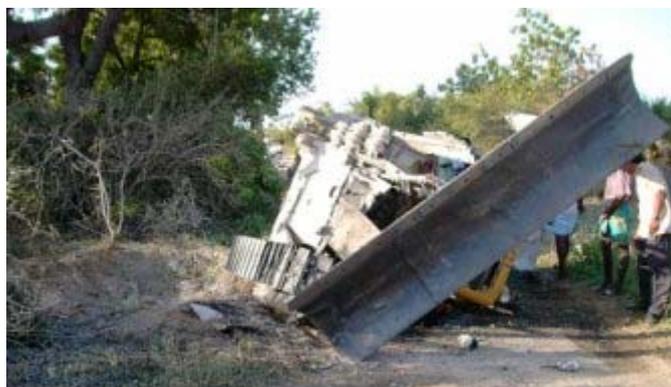
“A bulldozer and crew contracted by the GA and managed by the AGA was working in Malvil on the day of the incident. [Victim No.1], Bulldozer driver, [Victim No.2], Driver’s Assistant and [Victim No.3], AGA appointed foreman were tasked with levelling the SLA bunds and clearing excess vegetation around the village. Immediately prior to the incident the bulldozer was on the dirt road running through the village and attempting to turn around. As the bulldozer moved off the road in its attempt to turn, an explosion occurred under the right hand track, tipping the bulldozer over and throwing the three contractors away from the site.

[The picture above shows the bulldozer after the accident.]

“It is apparent that the direct pressure from the bulldozer activated a metallic anti-tank mine, while driving off the edge of a well used road. The mine appears to have been an M-15 anti-tank mine laid by the SLA as part of their defences in Malvil Village.

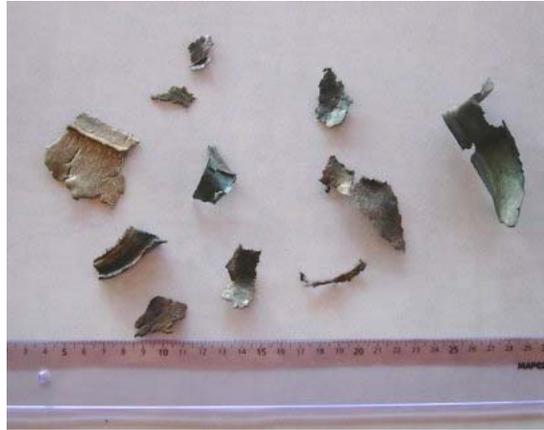
“Thin metal fragments were found in the crater left by the explosion. These fragments are consistent with that of an M-15 anti tank mine commonly used by the SLA.

[The picture above shows the recovered fragments.]
