# DDAS Accident Report

<b>Report date:</b> 02/08/2006	<b>Accident number:</b> 431
<b>Accident time:</b> 08:45	<b>Accident Date:</b> 07/08/2004
<b>Where it occurred:</b> BF 23003 Dararweyne bunkers	<b>Country:</b> Somaliland
<b>Primary cause:</b> Unavoidable (?)	<b>Secondary cause:</b> Other (?)
<b>Class:</b> Excavation accident	<b>Date of main report:</b> 12/08/2004
<b>ID original source:</b> Name removed	<b>Name of source:</b> Name removed
<b>Organisation:</b> Name removed	
<b>Mine/device:</b> Fuze	<b>Ground condition:</b> building rubble
<b>Date record created:</b> 02/08/2006	<b>Date last modified:</b> 02/08/2006
<b>No of victims:</b> 1	<b>No of documents:</b> 1

Accident Investigation Report

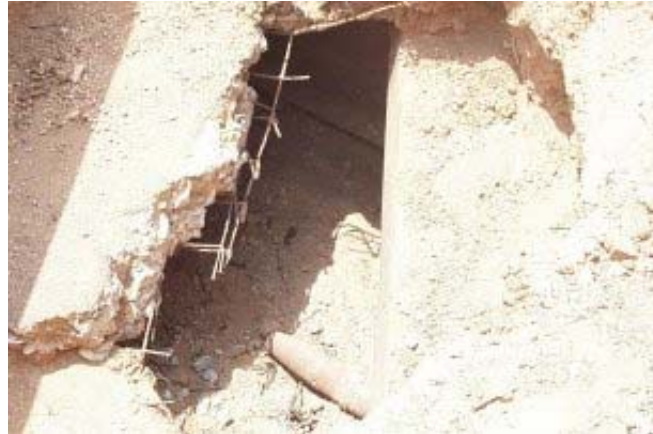
The injured deminer has hit the detonator

The area was been tightened and dim. [Confined space with poor light.]

[The photograph above shows] where the accident happened.]

The incident is classed as a "*Excavation incident*" because the victim had hand and leg injury and a photograph shows an accident site that implies the victim was reaching down into a cavity, perhaps with one leg inside the cavity when the fuze was initiated by his activity. The report states that he "hit the detonator" but does not explain what with, so a hand-tool is presumed.

\* Seek advice with the UNDP MA operational Advisor
