# DDAS Accident Report

## **INVESTIGATION REPORT OF DEMINING ACCIDENT IN JAFFNA 19 FEBRUARY 2006**

Accident date: 19th February 2006, Time: 13:20

Location: Mine collection point in minefield LK-241, SL Grid 0113885 0507031, Periyavillan, Valikamam Southwest, Jaffna

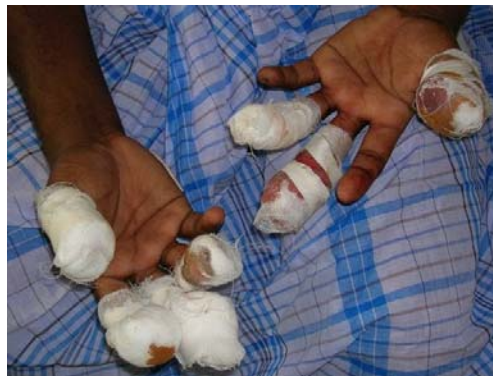
"...injuries to his left hand and right hand fingers [hands required surgery] and to the top of his left eye".

Code	Meaning	Check mark
A	Abrasions	X
AM	Amputation	X
B	Burn	
D	Dislocation	
F	Fracture	
FR	Fragment	X
H	Haemorrhage	X
IF	Internal Haemorrhage	
L	Laceration	
LO	Loss of function	X

And recorded that the tips of fingers had been amputated.
