# DDAS Accident Report

<b>Report date:</b> 17/03/2007	<b>Accident number:</b> 441
<b>Accident time:</b> 11:00	<b>Accident Date:</b> 08/10/2003
<b>Where it occurred:</b> Talailmannar Pier East, Mannar District	<b>Country:</b> Sri Lanka
<b>Primary cause:</b> Unavoidable (?)	<b>Secondary cause:</b> Field control inadequacy (?)
<b>Class:</b> Missed-mine accident	<b>Date of main report:</b> 11/10/2003
<b>ID original source:</b> SF, MF, CH: MAN/03/002	<b>Name of source:</b> Private
<b>Organisation:</b> [Name removed]	
<b>Mine/device:</b> Type 72 AP blast	<b>Ground condition:</b> building rubble electromagnetic hard metal fragments metal scrap residential/urban rocks/stones soft
<b>Date record created:</b> 17/03/2007	<b>Date last modified:</b> 17/03/2007
<b>No of victims:</b> 1	<b>No of documents:</b> 1

## **Internal Investigation Report: MAN/03/002**

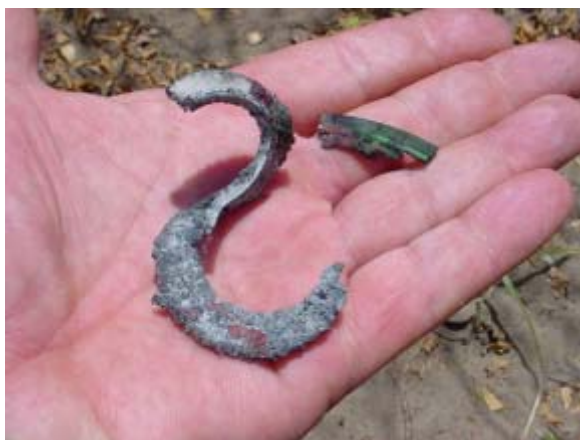
[Parts of the mine are shown below.]

The deminer was walking backwards and reaching the rear wall (his left foot must have had a distance of approx. 30cm from the wall/doorway) to fill his shovel again, as he must have stepped on the AP mine (Chinese Type 72 A) and an uncontrolled detonation occurred. The detonation caused the traumatic amputation of his left foot.

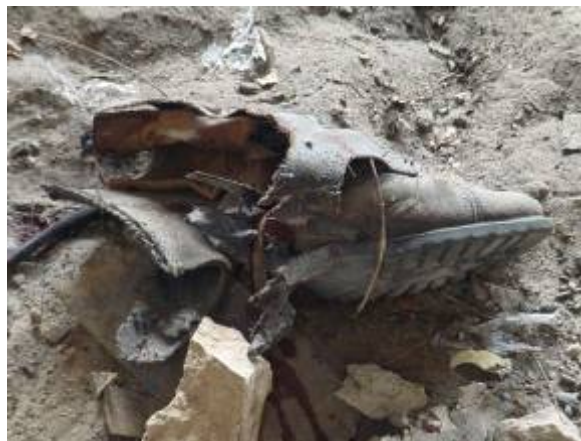
The Victim was wearing PPE and visor, and there was “no damage on PPE/Visor resulting to the blast or projection of plastic parts of the mine body”.

[The Victim’s left shoe is shown below.]
