DDAS Accident Report

Report date: 28/12/2007	Accident number: 443
Accident time: 10:40	Accident Date: 30/10/2006
Where it occurred: MF# AF/0308/01648/108 Bakhshikhail Village, Bagram District, Parwan Province	Country: Afghanistan
Primary cause: Management/control inadequacy (?)	Secondary cause: Field control inadequacy (?)
Class: Excavation accident	Date of main report: 19/11/2006
ID original source: SHA-333, OPS- 27/445/06	Name of source: UNMACA
Organisation: [Name removed]	
Mine/device: PMN AP blast	Ground condition: building rubble dry/dusty rocks/stones
Date record created: 28/12/2007	Date last modified: 28/12/2007
No of victims: 1	No of documents: 3

Demining Investigation Report

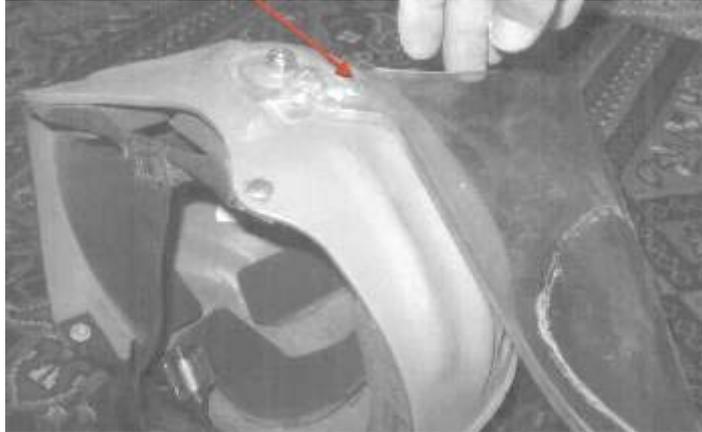
Equipment/property damage: Trowel was broken. [Visor was also broken.]

[The type of visor photographed often breaks in the place arrowed – even when not involved in a blast event.]

tool” despite the Bol’s opinion to the contrary. Its fragments could have caused severe injury. The visor also broke (this visor type frequently does in a blast) and it is uncertain whether this contributed to the victim’s eye injury.

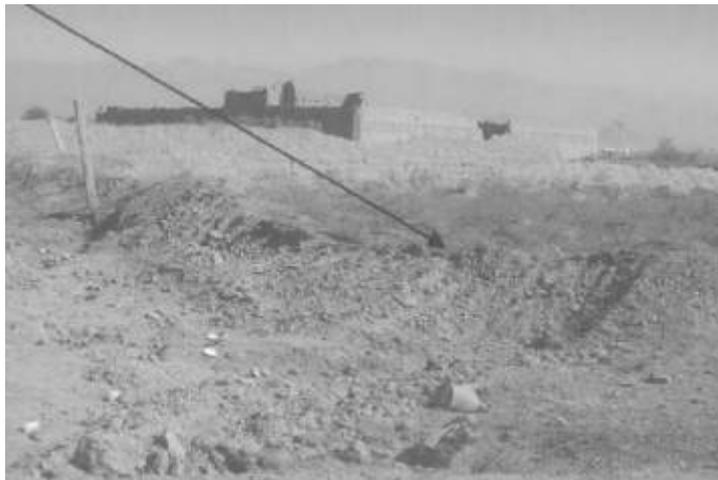
[A photograph of the site shows rocky ground (including rocks from the ruined wall) and no vegetation. The preparatory “raking” of the backhoe is clearly visible. There is inadequate area marking with no lane visible and no easy way to see what land has been cleared. The arrow points to the site of detonation.]

2. A ruined wall existed near the accident point, the machine should firstly had removed the soil of this wall then ripped the original surface of the ground with 30 cm depth, but as we saw the backhoe team has considered the surface of the ruined wall as original surface of the ground, so, they have ripped just surface of the ruined wall.

3. The ripping depth of the ground surface near the accident point was reduced from 30 cm to 10 cm. Reducing the ripping depth to 10 cm; may has changed the mine direction or broken it which makes the mine further sensitive.

1. The [Deminig group] operation section should make at least one qualified deminer of each team subject to TL courses.
2. Just ripping the site with backhoe machine is not enough for reducing the risk, but further exceeds the risk. The backhoe should remove the ripped soils to a cleared area, the removed soil should be visual checked by the backhoe section leader and then be checked by deminers with detector.

3. The backhoe operator should maintain the 30 cm depth while ripping the site, team leader and the relevant section leader should control that the required depth is maintained.

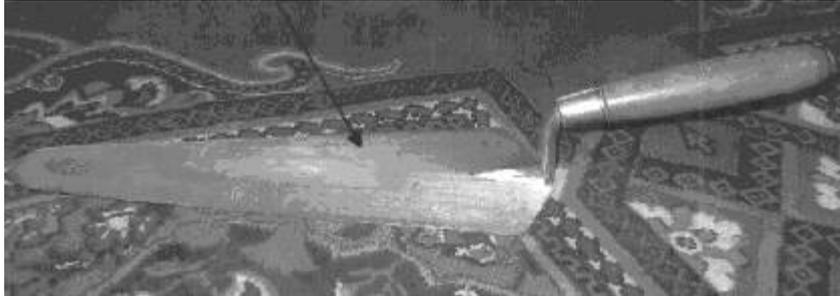
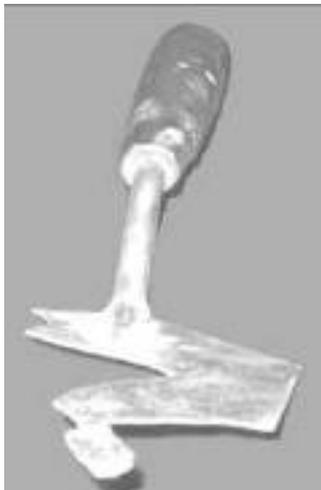
The inadequate equipment listed under "Notes" refers to the deminer's hand-tool and visor. The hand-tool was a plasterer's trowel that shattered dangerously. It was not an "appropriate

The pictures show the trowel before and after the initiation. The material shatters in a blast and so introduces a high risk of fragmentation injury to a blast event.
