DDAS Accident Report

Report date: 28/12/2007	Accident number: 444
Accident time: 09:00	Accident Date: 18/11/2006
Where it occurred: Task 104, Tower 62, Kabul Naghlu Power line, Butkhak village, Bagrami district, Kabul province	Country: Afghanistan
Primary cause: Inadequate survey (?)	Secondary cause: Field control inadequacy (?)
Class: Excavation accident	Date of main report: 28/11/2006
ID original source: OPS/27/447-06	Name of source: UNMACA
Organisation: [Name removed]	
Mine/device: PMN-2 AP blast	Ground condition: rocks/stones soft
Date record created: 28/12/2007	Date last modified: 28/12/2007
No of victims: 1	No of documents: 3

Subject: Follow up action on BOI report of accident (C-92) happened to the deminer of [Demining group] MCT-21 in task # 104, Tower 62 of Kabul Naghlu Power line in Butkhak village, Bagrami district of Kabul province

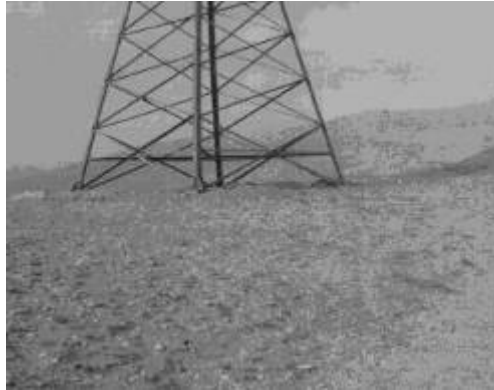
The accident occurred at the base of an electrical tower which forms part of the Kabul to Naghlu Power-line. The towers are numbered from the Kabul end of the line and the accident took place at Tower No 62.

[The accident tower.]

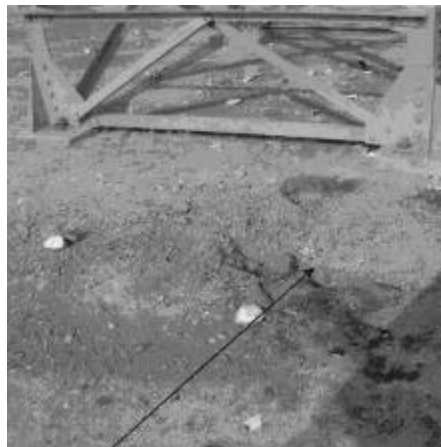
[The accident crater, showing little excavation.]

7. Excavation 62 was not being conducted in accordance with the [Demining group] excavation drill. The Acting TL and the SL both stated that they had instructed the deminers to have 20cm distance x 20cm depth of full excavation to their front at all times. The SOP states that there must be a minimum of 1m fully excavated and all spoil is to be at the rear of the deminer. It was evident at the scene of the accident that virtually no spoil was being removed at all.

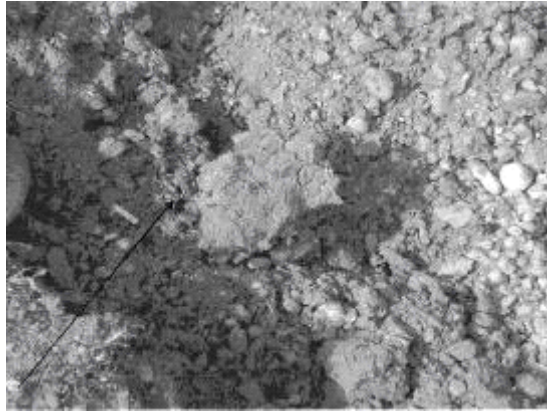
[The accident crater showing friable ground with pebbles.]
