DDAS Accident Report

Report date: 28/12/2007	Accident number: 445
Accident time: 07:04	Accident Date: 13/05/2007
Where it occurred: Bahadul-Gaig village, Jabal Seraj district of Parwan province	Country: Afghanistan
Primary cause: Inadequate training (?)	Secondary cause: Management/control inadequacy (?)
Class: Excavation accident	Date of main report: 16/05/2007
ID original source: OPS/03/01-38	Name of source: UNMACA
Organisation: [Name removed]	
Mine/device: PMN AP blast	Ground condition: agricultural (recent) building rubble hard residential/urban
Date record created: 28/12/2007	Date last modified: 28/12/2007
No of victims: 2	No of documents: 3

INTERNAL DETAILED DEMINING ACCIDENT REPORT

16 May 2007

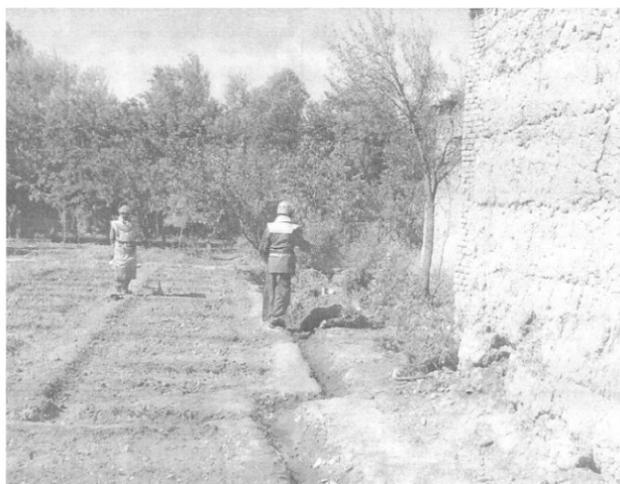
Worksite was marked in accordance with SOP. This demining task is outside a residential wall; the line is approximately 1.5m wide. 420 out of 470 m² were already completed when the accident occurred.

This picture shows the east side of the area outside house wall. The deminer is pointing to the detonation site of the first PMN.

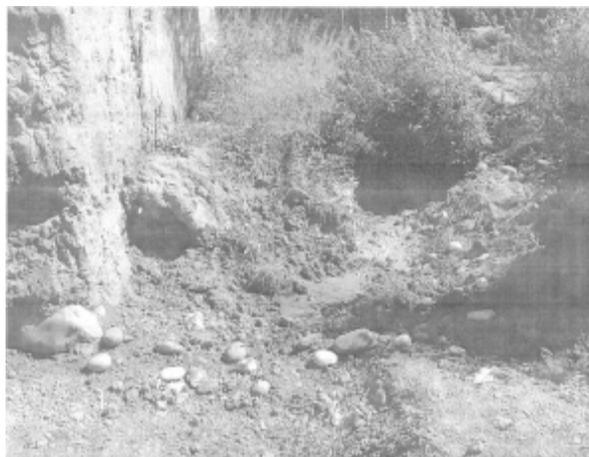
The location of the PMN detonation is approximately 70-80 cm from the green marking stone [centre of photograph]. This photo was taken the day after the accident. The blast hole is not clearly visible due to mud. Specific depth and size of the hole are not known.

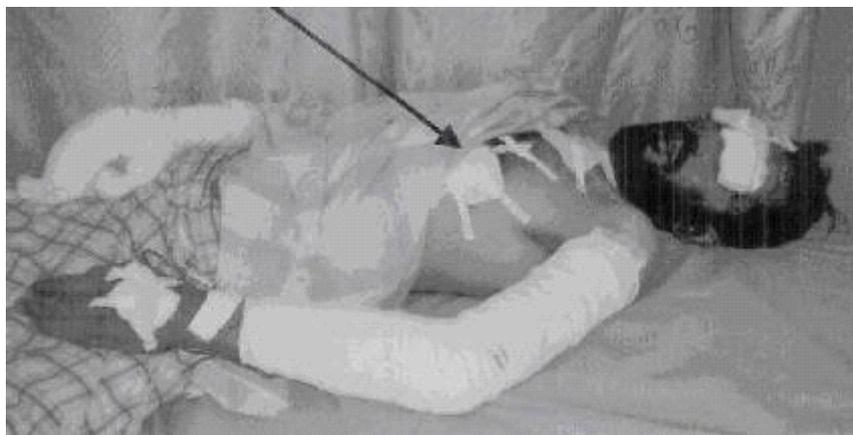
[Victim no.1] who was working as acting section leader received multiple injuries on his face, arms, hands and also a small hole created on his chest. "...has got his right eye completely damaged, left hand got injury and deep hurt in to near his And also left eye got injury".

Front parts of his body, parts around his right eye, some parts of his right and left hands and a hole at his chest which is not deep to affect important organs of his body.

[Victim no.1: dressed injuries to left hand, right arm, eyes and chest.]

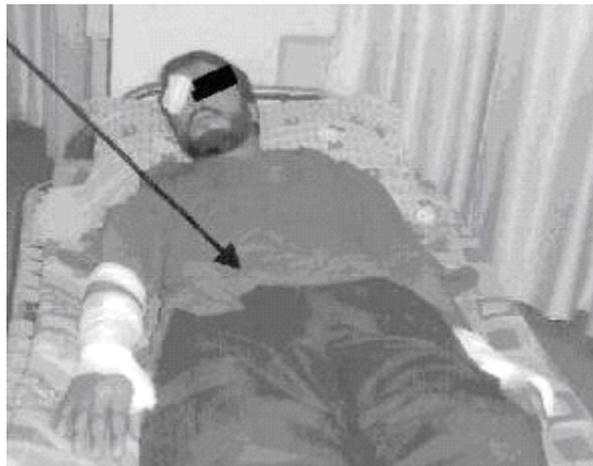
[Victim no.2] a deminer belonging to section # 2 who was standing close to [Victim no.1] (the acting section leader) received injuries on his hands, eyes and multiple superficial injuries on his face. "His right eye got injury but not serious, surface injury in his body and hands".

[Victim No.2: dressed injuries to both forearms and right eye.]

During this accident deminer [Victim no.2] was stand near the acting section leader received injuries on his hands, right eye and multiple superficial injures on his face.
