# DDAS Accident Report

<b>Report date:</b> 28/12/2007	<b>Accident number:</b> 447
<b>Accident time:</b> 08:35	<b>Accident Date:</b> 15/05/2007
<b>Where it occurred:</b> Bahadur Baig village, Jabal Seraj district of Parwan province	<b>Country:</b> Afghanistan
<b>Primary cause:</b> Unavoidable (?)	<b>Secondary cause:</b> Management/control inadequacy (?)
<b>Class:</b> Excavation accident	<b>Date of main report:</b> 16/05/2007
<b>ID original source:</b> OPS/03/01-39	<b>Name of source:</b> UNMACA
<b>Organisation:</b> [Name removed]	
<b>Mine/device:</b> PMN AP blast	<b>Ground condition:</b> agricultural (recent) building rubble hard residential/urban
<b>Date record created:</b> 28/12/2007	<b>Date last modified:</b> 28/12/2007
<b>No of victims:</b> 1	<b>No of documents:</b> 3

# **INTERNAL DETAILED DEMINING ACCIDENT REPORT**

16 May 2007

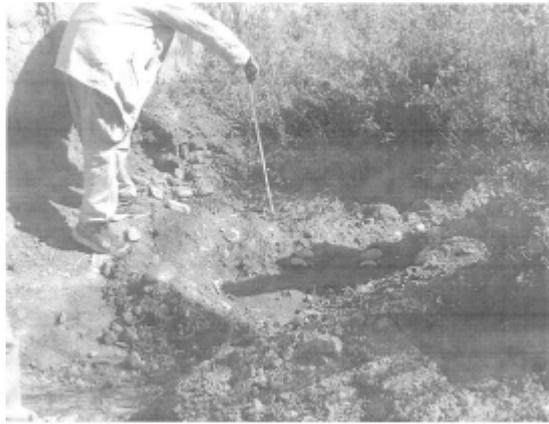
Accident cause: Detonation was caused by unintentional contact of the bayonet — type probe (prodder) by the deminer onto the top of the PMN.

Location of PMN detonation.

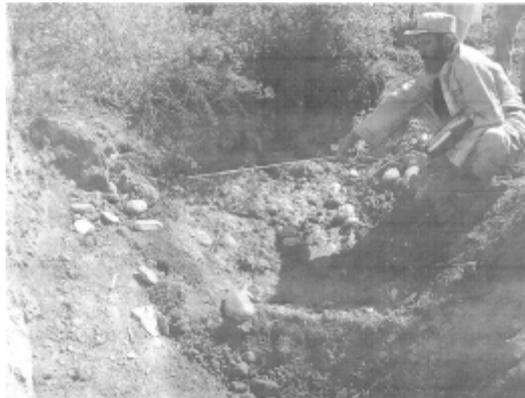
SL indicating the detonation location on east side of the wall on May 15.
