# DDAS Accident Report

<b>Report date:</b> 29/12/2007	<b>Accident number:</b> 451
<b>Accident time:</b> 10:55	<b>Accident Date:</b> 04/09/2006
<b>Where it occurred:</b> ME No-070719-013-021, All Khil village Jaji District, Paktya Province	<b>Country:</b> Afghanistan
<b>Primary cause:</b> Management/control inadequacy (?)	<b>Secondary cause:</b> Unavoidable (?)
<b>Class:</b> Excavation accident	<b>Date of main report:</b> 20/09/2006
<b>ID original source:</b> SE-05	<b>Name of source:</b> UNMACA
<b>Organisation:</b> [Name removed]	
<b>Mine/device:</b> PMN AP blast	<b>Ground condition:</b> dry/dusty hard rocks/stones
<b>Date record created:</b> 28/12/2007	<b>Date last modified:</b> 29/12/2007
<b>No of victims:</b> 1	<b>No of documents:</b> 2

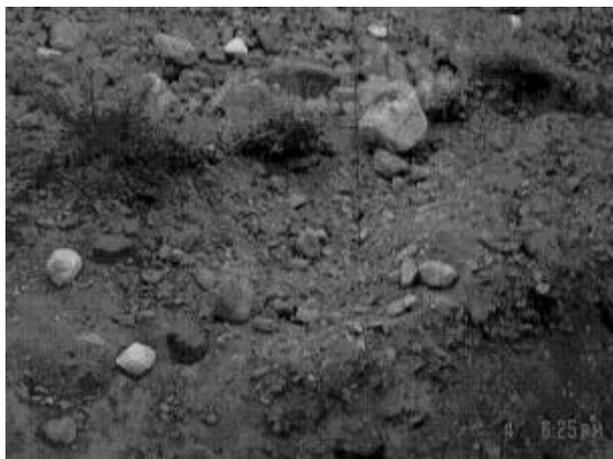
[The accident site – showing rocky ground with sparse vegetation and sparse area-marking.]

[Derived from IMSMA report forms: Ground was uneven, open hillside. Soil was hard and dry. Weather was clear, calm and mild. Vegetation was grass and bush and rocky [sic].]

Since the area is uneven and hillside with bushes and density of mines, therefore, the position of mine was changed by backhoe during the area preparation. As the area is prepared by MDU and was soft, there was no need for Bayonet excavation. In fact deminer[s] made faults including section leader even team leader.

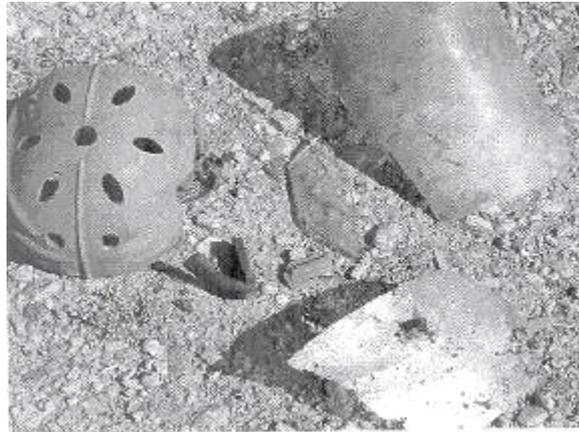
As a result of the explosion, a Bayonet, Helmet Visor and PPE (Personnel Protective Equipment) have got damaged.

[The Victim's visor (helmet mounted) had broken again – and this may have added to his facial injury. The design of these visors includes weaknesses that make breakage common.]

The "Inadequate equipment" listed under "Notes" refers to the visor, the design of which means that it breaks frequently during accidents (when other designs do not). The "Inadequate medical provision" listed under "Notes" refers to the fact that the CASEVAC took more than seven hours, which is an unacceptable breach of IMAS. The "Inadequate investigation" listed under "Notes" refers to the fact that the investigation was not detailed, very repetitive and frequently incoherent. The "Pressure to work quickly" is reported in the statements of deminers (see Statements).
