DDAS Accident Report

Report date: 30/12/2007	Accident number: 452
Accident time: 07:45	Accident Date: 24/07/2006
Where it occurred: MF No-070719-013-021, Ali khil village, Jaji District, Paktya Province	Country: Afghanistan
Primary cause: Unavoidable (?)	Secondary cause: Inadequate equipment (?)
Class: Excavation accident	Date of main report: 24/07/2006
ID original source: QM.2.4.03/139.006	Name of source: UNMACA
Organisation: [Name removed]	
Mine/device: PMN AP blast	Ground condition: dry/dusty hard metal fragments rocks/stones
Date record created: 30/12/2007	Date last modified: 30/12/2007
No of victims: 1	No of documents: 2

SUBJECT: ATC DEMINING ACCIDENT ID NO E-04

Initial Demining Investigation Report

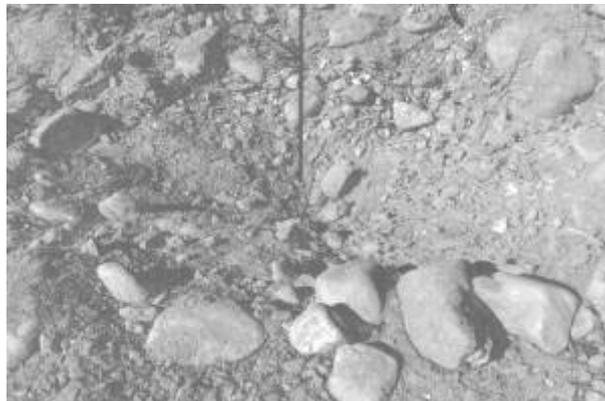
The ground was hard because of draught and sand.

[A photograph of the crater showed that the ground was rocky.]

The area has been observed by investigation team, and the area was uneven and hillside. The position of mine might be changed by floodwater.

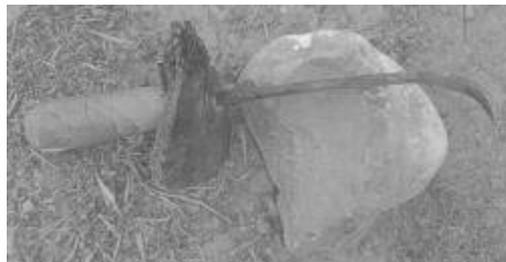
The primary cause of this accident is listed as “Unavoidable” because it seems that the Victim may have been working as directed when the accident happened. The locally made bayonet stayed in one piece and may have reduced the Victim’s injury, but the deminers recognised that the use of the bayonet as an excavation tool may not have been the best choice. The use of the metal detector clearance in an area with a lot of metal fragmentation (and no strong magnets) may also have been unwise. The deminers wanted to prepare the ground mechanically but the machine was busy elsewhere. Because appropriate equipment and systems to conduct the task in safety were not in place, the secondary cause is listed as “Inadequate equipment”.

A photograph showed that the Victim’s bayonet bent as designed and the hand-guard (the side-wall of a tyre) seems to have done its job. The Victim’s hand injuries may have occurred when it was violently twisted from his hand.

I recommend: One Hitachi MDU to be sent to the area for preparation of the area for manual team. New equipments should be provided such as HF and VHF Radios and Visors.
