DDAS Accident Report

Report date: 03/01/2008	Accident number: 454
Accident time: 14:15	Accident Date: 04/05/2006
Where it occurred: Khoshal Khan Hostel Complex, Dasht-i-Padola, Chehelstoon, Kabul City	Country: Afghanistan
Primary cause: Field control inadequacy (?)	Secondary cause: Management/control inadequacy (?)
Class: Mechanical excavation	Date of main report: 29/05/2006
ID original source: Ops-27/266/06	Name of source: UNMACA
Organisation: [Name removed]	
Mine/device: M-19 AT blast	Ground condition: dry/dusty
Date record created: 03/01/2008	Date last modified: 03/01/2008
No of victims: 1	No of documents: 2

Subject: Demining Incidents Investigation Report

Demining Investigation Report

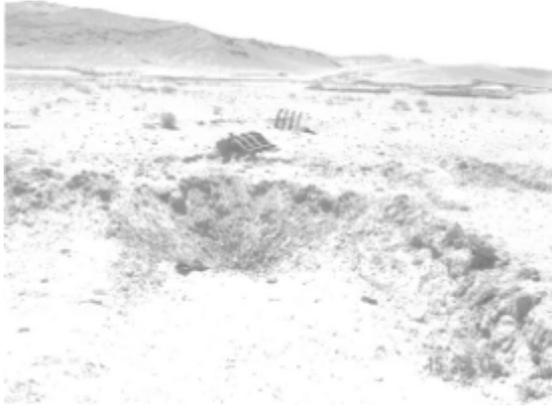
The second incident mine was located downside up a small hill, as the sediment soils during many years has gathered on and around the place of accident.

In the second accident, the mine exploded under and the bucket blocked the middle of the loader bucket as the top of the mine, so, the pressure of the mine could not spread out. Therefore, it made a big hole in the bucket and dig out the ground vaster and deeper as compared with the first explosion.

In the second accident, the explosion occurred near a hill as the excavation depth should be considered the maximum assigned depth which is 70 Cm, but as we saw the site it has not been considered during excavation.

The out look of the second incident place.

Technical survey should be conducted at first in order to collect more and precise information about the site situation, depth of mine; mine type etc prior to starting clearance operation.

The team should meet clearance depth from original ground surface.

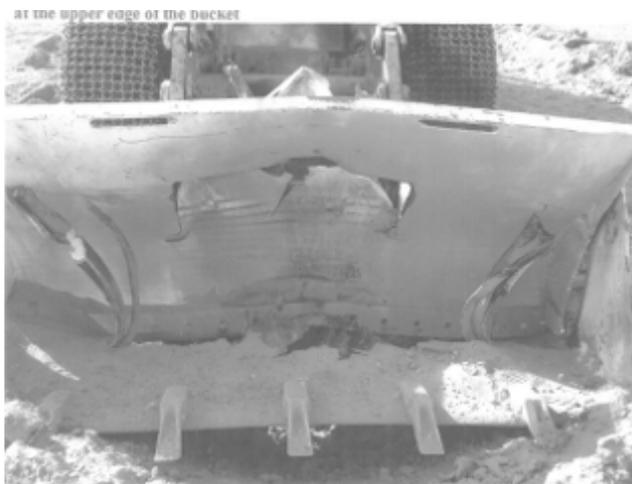
2. On 04 May, 2006 approximately 14:15 hrs the second anti tank mine exploded under the bucket of the said loader. The type of this mine also was M-19 and the depth of the mine was about 40 cm. The second incident created a large hole having about 30 cm radius in the middle down side and up edge of the bucket and the pipes of the loader hydraulic system was also defected. This explosion was too powerful as compared with the first explosion. The second explosion caused no casualties but due to powerfulness of the explosion the loader operator although had no physical injuries, went to shock.

In the second incident the explosion made two holes one at the bottom and the second at the upper edge of the bucket.
