DDAS Accident Report

Report date: 03/01/2008	Accident number: 456
Accident time: 10:00	Accident Date: 30/07/2002
Where it occurred: CMT Minefield, Pailin	Country: Cambodia
Primary cause: Management/control inadequacy (?)	Secondary cause: Inadequate equipment (?)
Class: Missed-mine accident	Date of main report: 01/08/2002
ID original source: None	Name of source: CMAC
Organisation: [Name removed]	
Mine/device: Type 72 AP blast	Ground condition: hidden root mat rocks/stones woodland
Date record created: 03/01/2008	Date last modified: 03/01/2008
No of victims: 1	No of documents: 2

INVESTIGATION REPORT INTO MINE ACCIDENT WHICH OCCURRED ON 30 JULY 2002
AT CMT MINEFIELD, PAILIN

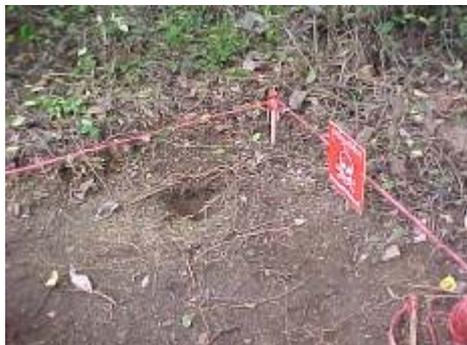
[The accident site]

The [Demining group] CMT Team had just commenced clearance operations at the hill top Pagoda site the same morning as the accident. Part of the team was clearing an area close to a stream bed at the bottom of the hill which has a lot of rocks and other vegetation. The immediate area above the site is very steep with loose metal.

Yes. A bulldozer has been used to level the top of the hill and has pushed gravel and stones down the sides of the hill. It is also an old Pagoda site so there is a lot of rubble around. A lot of bush exists at the base of the hill around the stream which also makes it very difficult to demine.

5. Based on the evidence, it is the inquiry teams opinion that the cause of the accident was that of a yet another deeply buried Type 72A mine, too deep to be detected and missed in the clearance of the lane.

Recommendations7. The investigation team after consideration of all factors makes the following recommendations:a. As with all previous investigations involving missed deeply buried Type 72A mines, [Demining group] must very quickly investigate either internally within [Demining group] or the Cambodian demining community or Internationally, to assist in helping seek a solution to this now [Demining group] wide problem. [Demining group] can ill afford to continue to hold off on finding a speedy solution or risk being held accountable for the mounting casualty rate.

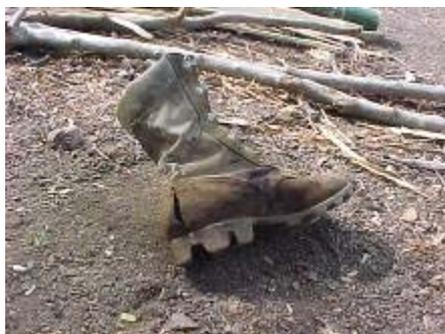
[The victim's boot.]

Based on the physical evidence, a missed deeply buried Type 72A Anti Personnel Mine.

The deminer suffered a blast injury to his left foot that later required amputation above the ankle.
