DDAS Accident Report

Report date: 04/01/2008	Accident number: 458
Accident time: 12:00	Accident Date: 07/03/2004
Where it occurred: MF ID 11161, Podhum, Mostar	Country: Bosnia Herzegovina
Primary cause: Victim inattention (?)	Secondary cause: Unavoidable (?)
Class: Victim inattention	Date of main report: 17/03/2004
ID original source: None	Name of source: BHMAC WL
Organisation: [Name removed]	Ground condition: leaf litter rocks/stones wet woodland
Mine/device: PMA-3 AP blast	
Date record created: 04/01/2008	Date last modified: 04/01/2008
No of victims: 1	No of documents: 1

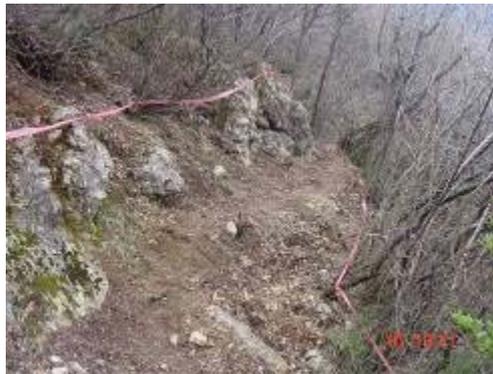
The minefield (ID 11161) is in Podhum, a suburb of the town of Mostar. It is two km from the town centre, below a hill named "Hum", just above the houses in Podhum. The eastern border is a demined area (ID 10060), the western border is a suburb Panjevina. There were no available minefield records. The terrain is on a hillside, partially stony and partially grown with dry grass and bushes, there are some trees. There are visible traces of burning from the years before. The soil is clay mixed with stones and dry leaves. At the time of accident, the surface was soft due to rain, but inadequate for prodding, because of the stones and the thin layer of soil, below which there is only stone. The temperature was 15 degrees. Animals and previous fires had activated some mines in the past.

[The worksite was very steep through light woodland and over rocks.]

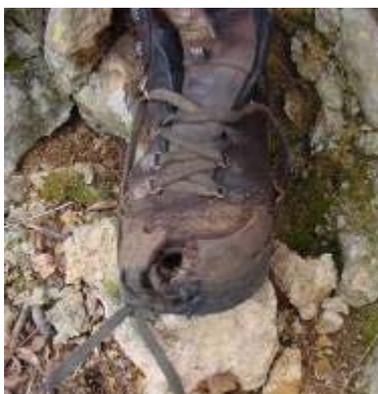
[The Victim] was going away from the lane. At about 10 m distance from [Name removed], who approached the base line, he slipped with his left foot below the tape into a non-examined part of the minefield and activated a PMA-3. The working path was narrower there because of a larger rock. After the explosion, [the Victim] fell into the working path, but with his legs lying in the non-examined part. Deminer [Name removed] pulled him out into the cleared part. The tip of the left shoe was damaged. It was taken off.

[The Victim's right boot.]

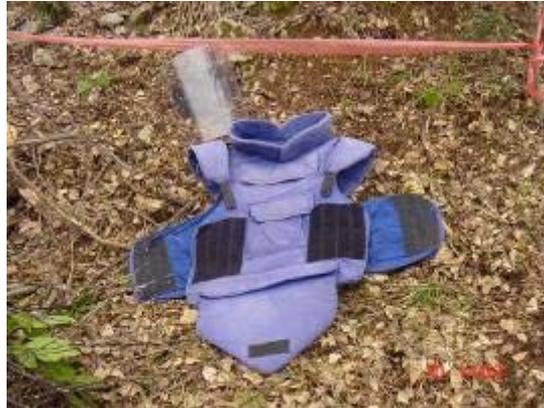
[The victim's PPE at the site. Showing no marks at all.]

The Victim's face injury makes it likely that the Victim's visor was not worn or was worn raised. The cleanliness of the PPE shown in the photograph suggests that it may not been worn at the time.

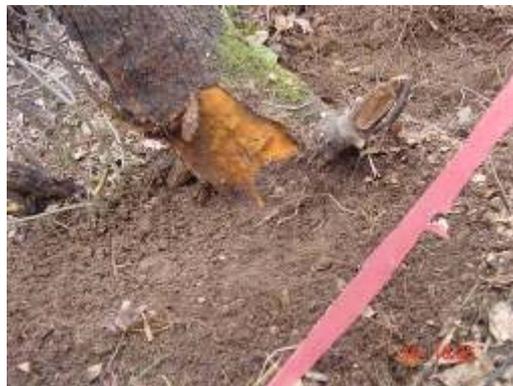
A PMA-3 was about 28 cm from the centre of the tape [parts were found and photographed]. There was a stone on the mine, which probably activated it. The main power of the blast was directed to a nearby tree, which was quite damaged.

[The seat of the explosion and the damaged tree.]

This implies that the position of the mine was tilted sideways, following the slope of the hill. It might have been placed horizontally and been moved with time. There was no crater: the mine was not buried in the ground, it was just masked with some soil, leaves and a stone. This conclusion is confirmed by some signs of burning.

It is recommended to perform regular additional training of deminers. All signals should be investigated – if not possible with a prodder, than they have to be excavated. It is recommended to use magnets to pick up metal fragments. More attention should be paid to internal quality control, especially by the team leader, who should return the deminers to clear the area in case of errors.
