DDAS Accident Report

INCIDENT REPORT

MINEFIELD TASK ID - NS - 10 - 02

SECTOR- NORTH SOUTH, PLACE - BEYR MATHKOUR, REGION - WADI ARABA

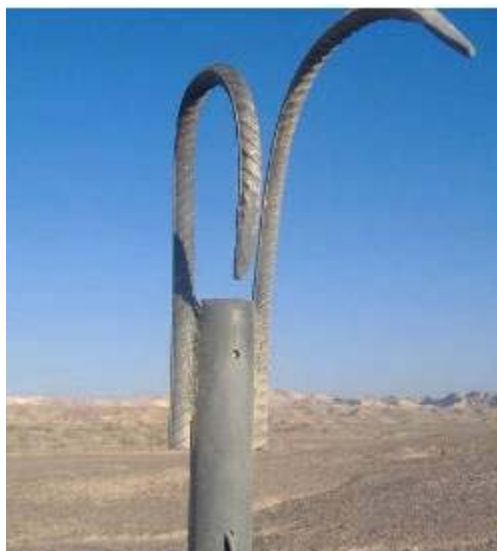
A [Demining group] Manual Team One, deminer hit a No.10 AP mine from the top that resulted in a mine blast. The deminer suffered no injuries. He was wearing his protective Vest and Goggles. [Photographs of both Victim and PPE showed no damage.] The tines of the heavy rake were bent.

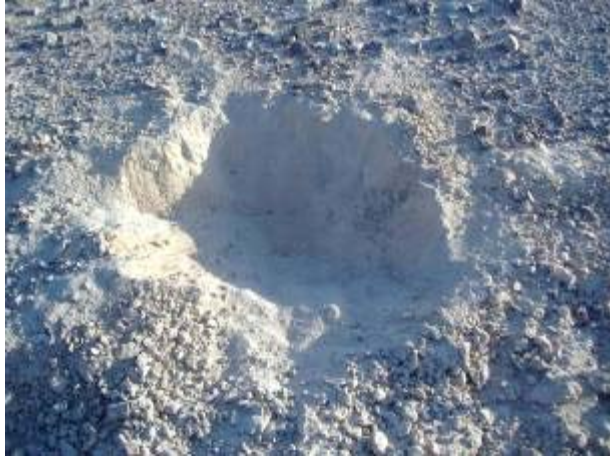
The crater left by the initiation was approx 15cm deep and 30cm wide.

The primary cause of this accident is listed as a "Field control inadequacy" because the photographs show that the initiation occurred outside the lane (marking is achieved by side of lane trenches) on ground that had not been "brushed" with the Light rake. In the correct procedure, the Light rake is used before the Heavy rake. It seems that Victim was working in

a manner that conflicted with authorised procedures and his mistake was not corrected. The secondary cause is listed as “Unavoidable” because there is not enough information in the report to be certain of the cause, and the deminer may not have been at fault.
