DDAS Accident Report

Report date: 29/04/2008	Accident number: 481
Accident time: 09:35	Accident Date: 19/04/2006
Where it occurred: Halkayor village, Panj district, Khatlon Region	Country: Tajikistan
Primary cause: Management/control inadequacy (?)	Secondary cause: Inadequate training (?)
Class: Other	Date of main report: 26/04/2006
ID original source: None	Name of source: TMAC
Organisation: [Name removed]	
Mine/device: PMN AP blast with ML-7	Ground condition: grass/grazing area hard rocks/stones
Date record created: 17/01/2008	Date last modified: 29/04/2008
No of victims: 2	No of documents: 2

BOARD OF INQUIRY INTO DEMINING ACCIDENT ON 19 APRIL 2006

Dushanbe 26 April 2006

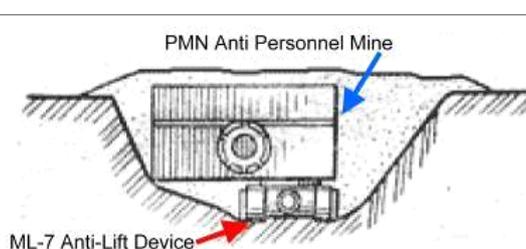
53. Fragments recovered from the crater created by the blast of the explosion show that the mine involved was a Russian PMN anti-personnel blast mine, coupled together with a ML-7 booby-trap switch. Crater left by the detonation is as would be expected from expected from such a device.

54. A PMN anti-personnel mine is loaded with 249 grams of high explosive. It is designed to be operated by 8 to 25Kg of pressure from above.

55. An ML-7 booby-trap switch is loaded with 40 grams of high explosive. It is designed to be operated by the removal of 4Kg pressure.

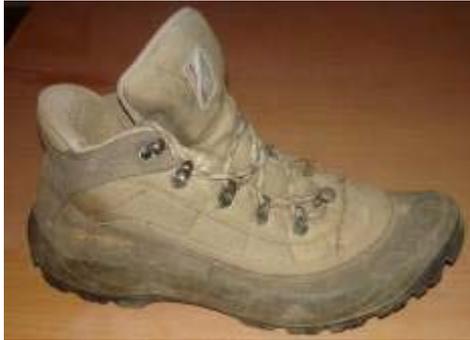
The second boot is shown below.

Although it seemed at first that Victim No.1 must have deliberately entered the minefield, a subsequent discovery throws doubt onto that explanation. Months later, Victim No.1’s second boot was found further into the minefield – with no sign of damage. The only explanation for this is that it was not being worn at the time. It may be that Victim No.1 took off his shoe, perhaps to remove a stone, and stumbled into the mined area. Certainly he was at least 30cm inside the mined area and in a squatting or crouching position when he initiated the PMN, (boosted with an ML-7). If the boot was in his hand it could have been thrown aside by the blast. Close examination shows no damage

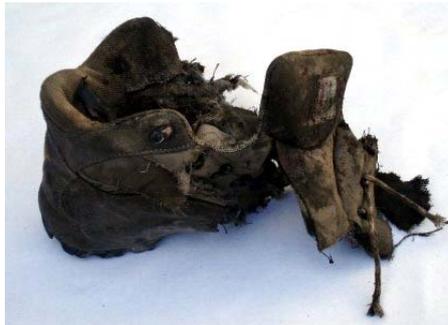
The first boot is shown below.

61. At the time of the explosion, [Victim No.1] was wearing lightweight hiking boots, as shown in the image at Annex M. The right boot was severely and extensively damaged; the sole was cut and a large part of the boot's upper was ripped and frayed from the effects of the explosion as it was blasted away from his foot. The other boot has not so far been found and it is most likely that this was completely annihilated during the detonation which destroyed the lower part of [Victim No.1]'s left leg. [The second boot was later recovered entirely intact.]
