DDAS Accident Report

Report date: 18/01/2008	Accident number: 486
Accident time: 07:35	Accident Date: 11/11/2006
Where it occurred: Bedak Village, Gul Dara District, Kabul Province	Country: Afghanistan
Primary cause: Inadequate training (?)	Secondary cause: Inadequate equipment (?)
Class: Excavation accident	Date of main report: 06/12/2006
ID original source: OPS/27/470-06	Name of source: UNMACA
Organisation: [Name removed]	
Mine/device: PMN-2 AP blast	Ground condition: rocks/stones wet
Date record created:	Date last modified: 18/01/2008
No of victims: 1	No of documents: 2

IMSMA Demining Investigation Report

Report dated 30th November 2006

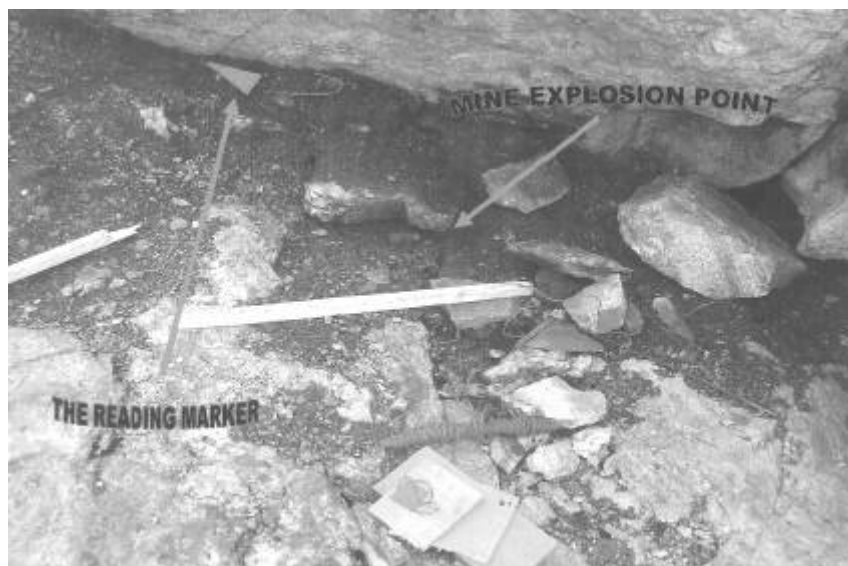
During excavation the deminer has brought pressure to the “scraper” on a PMN-2 mine causing the explosion.

[The accident site is shown below.]

The investigation team concludes the accident that as per indication of the trowel damage, the accident has happened due to touching of the trowel to the PMN2 mine. As the operation manager also told us that, the mine was under the stone. In this case the position of the mines may have changed and the trowel head has touched the mine and caused the accident.

1. All deminer must do the excavation very slow and calm.
2. They should maintain one detector head distance for putting the reading marker from the center of signal.
3. They must concern the angle of the excavation to not touch the top of the mines.
4. All command Groups must properly check and control their deminers closely especially while they excavate a signal.

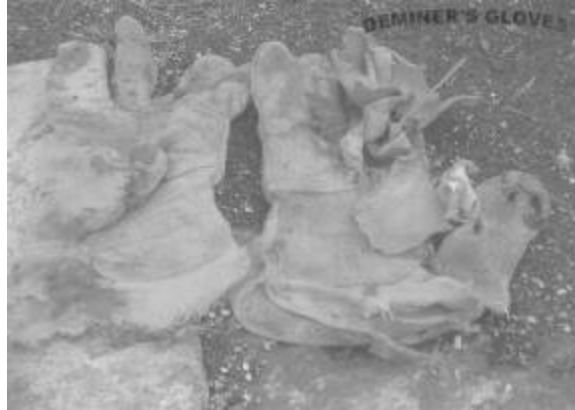
Description of equipment damage: The scraper, Visor, PPE Wooden Stick, trowel, Stand of the detector and the gloves had got damaged.

[The Victim's gloves are shown below. The damage to them, and the blood on the body armour (photo reproduced elsewhere) imply that the injuries may have been more severe than the demining group acknowledged.]

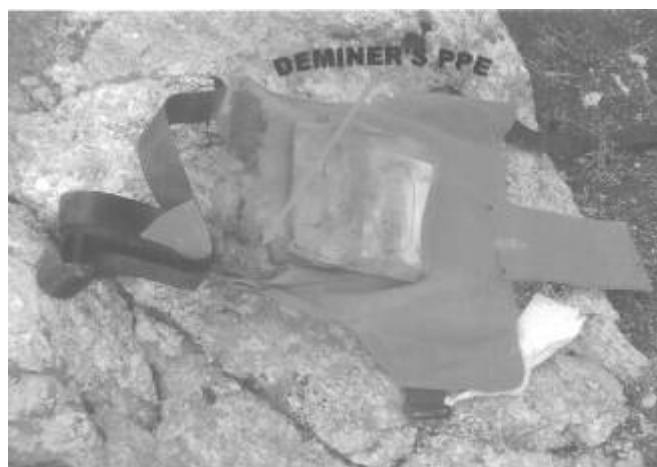
The primary cause of this accident is listed as “Inadequate training” because the investigators determined that this was a prime cause. The secondary cause is listed as “Inadequate equipment” because the large builder’s trowel issued to the deminer was an inappropriate tool and the demining group’s body armour failed to protect the Victim.

[The victim’s PPE with no collar to interface with the visor is shown below. There are blood stains at the top.]

With the minimal frontal vest favoured by this demining group, there is nothing to prevent blast debris entering below the visor. This vest and visor does not meet the IMAS and is unsafe. This International NGO’s deminers frequently suffer facial injury and eye loss. This should have made them reconsider their protection years ago.

In this instance, it is probable that the visor was also worn raised because the Victim suffered a nose injury that appears to have bled significantly.
