DDAS Accident Report

Demining Accident Report

Location: Qala e Zini, Balkh District, Balkh Province: Coordinates: E: 067 44 09.5: N: 36 44 09.2: WGS 84, GPS. GPS Name, GARMIN: accuracy at the time of fixing coordinate 5m.

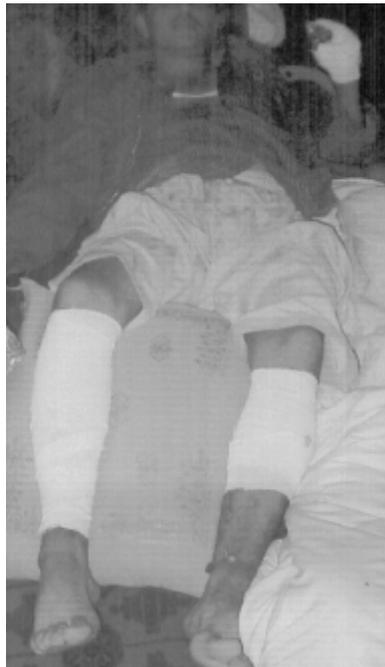
Description of Injuries: He got some injuries not serious without any amputation on his hands and legs. The detailed report of this injury will send after investigation. Over all condition of his health is not threatened he is conscious and talking.

[The bandaged Victim is shown below. Injuries indicate that he was squatting with his shins facing the detonation.]

Injuries: both legs injured. Left hand injured.

Fuzes from mortar bombs are not normally touch sensitive. If this area included touch-sensitive fuzes and the deminers were to recover them working in a squatting position and without first using metal-detectors to determine their approximate location, frontal aprons that hang in front of the shins should have been considered.

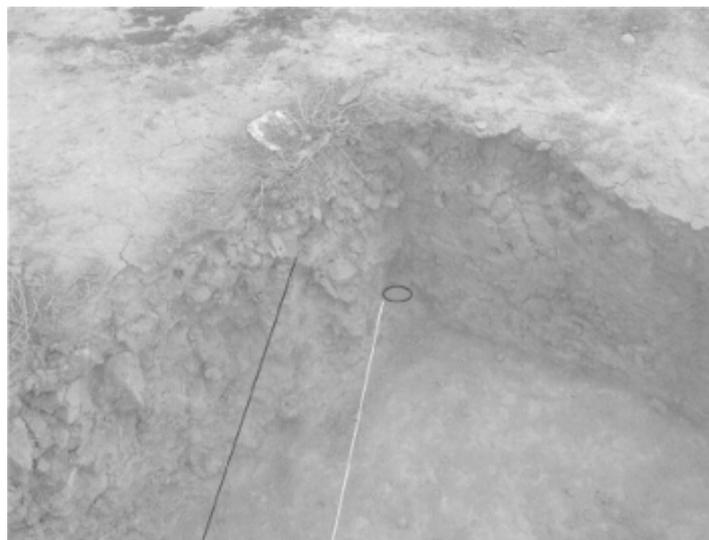
Apparently the accident has occurred in the clearance lane of the de-miner and seems that due to the hit of the fuse by trowel the 82mm mortar fuse has detonated during the excavation. There were not available any kind of piece(s) of the mentioned blasted fuse. The 12.7mm artillery was very close to fuse which was buried in the ground and can't seen. At the result the mentioned artillery front point just damaged.

The accident point did not look that blast occurred their but looked drops of blood in the mentioned point.

[The accident site is shown below: the point of detonation is circled and blood splashes indicated.]

cause(s), well judgement and for well identification of the problems in the accident site, and blasted site must be protected/guarded as safe without changing. While in the mentioned accident the accident point was look changed otherwise wasn't any sign of demolition just seen drops of blood.
