# DDAS Accident Report

<b>Report date:</b> 01/02/2008	<b>Accident number:</b> 497
<b>Accident time:</b> 07:40	<b>Accident Date:</b> 09/07/2007
<b>Where it occurred:</b> Qalai Gulay Village, Bagram District, Parwan Province	<b>Country:</b> Afghanistan
<b>Primary cause:</b> Field control inadequacy (?)	<b>Secondary cause:</b> Inadequate training (?)
<b>Class:</b> Excavation accident	<b>Date of main report:</b> Not recorded
<b>ID original source:</b> None	<b>Name of source:</b> UNMACA
<b>Organisation:</b> [Name removed]	
<b>Mine/device:</b> AP blast (unrecorded)	<b>Ground condition:</b> bushes/scrub rocks/stones
<b>Date record created:</b>	<b>Date last modified:</b> 01/02/2008
<b>No of victims:</b> 1	<b>No of documents:</b> 1

### OF DEMINING ACCIDENT OCCURRED ON [demining NGO] DEMINER ON JULY 09 ,2007 AT QALAI GULAY VILLAGE OF BAGRAM

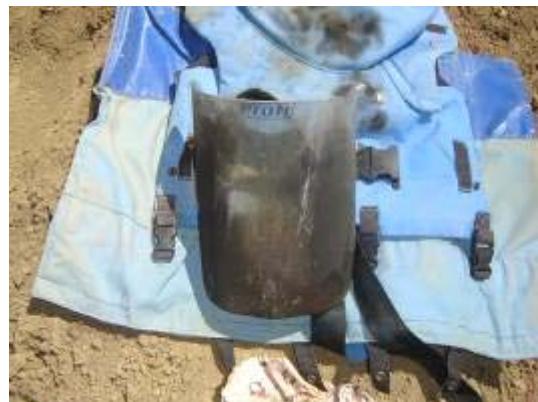
1. The two items of equipment (trowel and apron) both received blast/burn scorch marks as a result of the detonation, together with minor injuries to the deminer right hand and extensive peppering of the deminer face are consistent with the blast /burn effects experienced in many similar accidents. This directs the investigation team to conclude that the visor was not worn during the detonation of the mine.

2. Further, the intense blast/burn scorch marks to the central base of the visor indicate that this area of the visor was in very close proximity to the seat of detonation.

3. Additionally, in view of there being no blast/burn marks to the underside of the chin, or the exposed neck and no burning or singeing of the beard, the team concludes that the visor was nor worn in the correct position or more probably that it was not worn at all.

[The Victim's PPE – clearly showing soot inside the visor.]

The primary cause of this accident is listed as a “Field control inadequacy” because the investigators determined that the Victim was not wearing his visor in the down position at the time of the accident. Not only was this error not corrected, it is implied that the visor was deliberately damaged after the event in order to give a false impression that it was being worn at the time.

A full day of refresher training shall be conducted immediately for all 6 + 3 (JMAS) demining teams. The training subjects shall be the demining drills with a special concentration on the use of PPE combination of visor and vest and shaving the soil by using the small trowel.

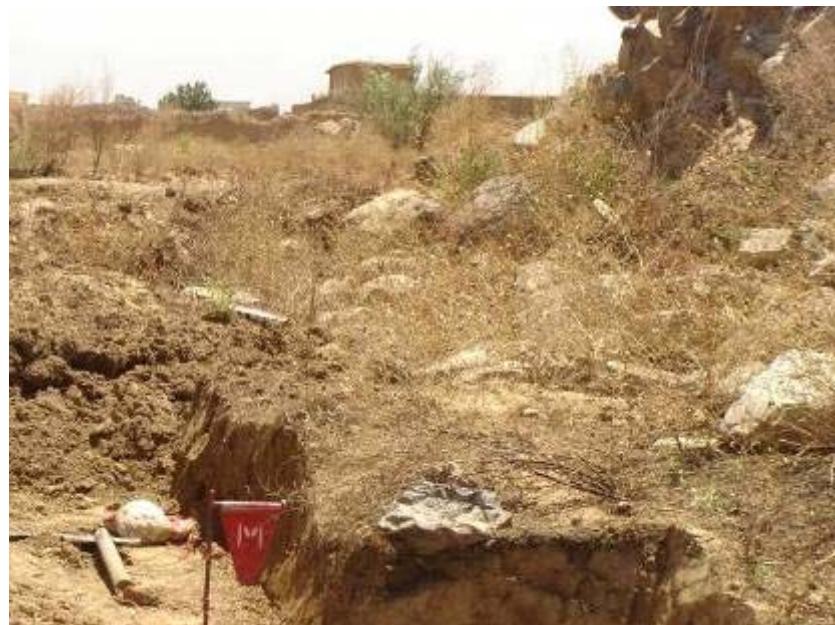
[Accident site: crater lower left.]

Within the immediate surroundings to the crater, there were numerous spots indicating the impact of artillery shelling, a Chinese 82mm recoilless projectile lying on the ground (0,5 m from the accident point), and a large amount of soil piled up in the explosion to the left side of the crater – indicating together with the injuries of the deminer and the damage to the property, that the mine was lying at an angle - not in horizontal position.

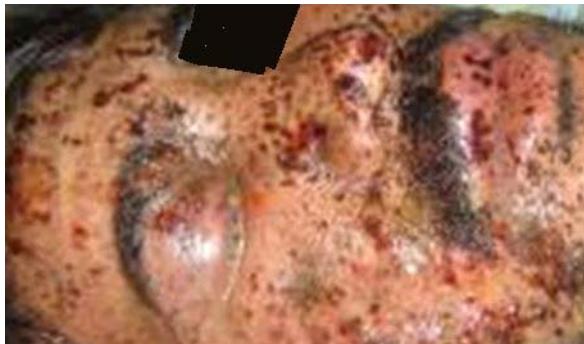
- A. Multiple erosive fragmental injuries on the face, frontal and 1st degree burns all over the face and frontal anterior view.
- B. Erosive fragmental injuries on dorsal view on right hand lateral side.
- C. Both eyes slightly injured and the right eye serious corneal defect.
- D. A fragmental wound in right side of the face include the ear auricular and an injury on the right eyelid.

E. Bruise injuries in chin and neck.
