DDAS Accident Report

Report date: 22/01/2008	Accident number: 499
Accident time: 12:00	Accident Date: 11/02/2007
Where it occurred: MF No. 0073, Kalata-l-Nayeb Ghafoor Village, Kohsan District, Herat Province	Country: Afghanistan
Primary cause: Inadequate survey (?)	Secondary cause: Inadequate training (?)
Class: Missed-mine accident	Date of main report: 12/02/2007
ID original source: MDU-06/MCT-17	Name of source: UNMACA
Organisation: [Name removed]	
Mine/device: PMN-2 AP blast	Ground condition: dry/dusty hard rocks/stones
Date record created:	Date last modified: 22/01/2008
No of victims: 0	No of documents: 2

Subject: [National demining NGO] Missed Mine Investigation Report

Missed Mine Accident Occurred on a [National demining NGO] MDU-06 on 12 Feb-2007

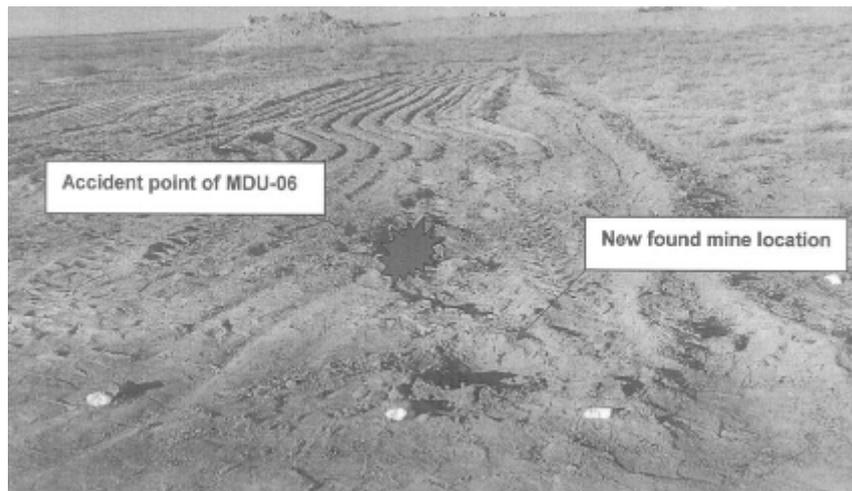
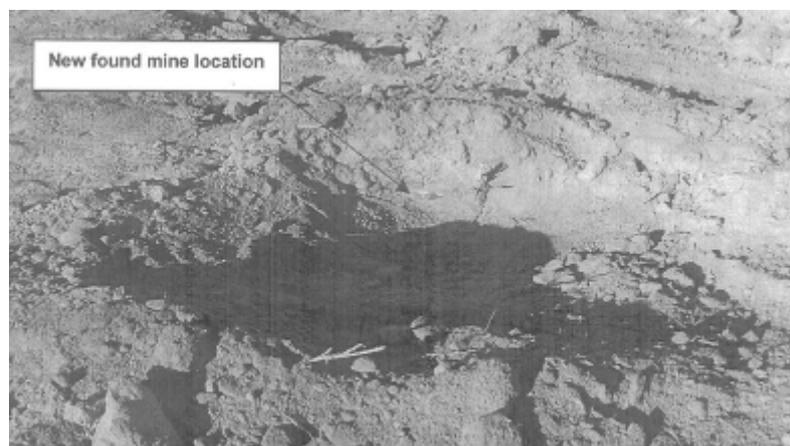
Description of the accident: On 11 Feb-2007 about 12:00 PM [National demining NGO] MDU-06 was working as a supporter with [National demining NGO] MCT-17, a PMN-2 missed mine accident occurred on MDU-06 machine in the cleared area, while the mentioned MDU was busy in preparation of minefield hazard area for MCT-17 breaching parties of section No-1. In the result backside right tire of Backhoe got damaged and no human casualty.

Photo of accident point on Backhoe Machine in Minefield No- AF-2008/18355/0073.

This portion of minefield No-AF-2008/18355/0073 where the accident of an anti personal PMN-2 mine occurred by [National demining NGO] MDU-06, was prepared by the mentioned MDU for the manual breaching party of section-1 of MCT-17, and was also searched and detected by the mentioned section party about 20 m long and 10 m wide. But when the MDU machine was getting ready for the preparation of another unclear portion for the mention party, when the MDU entered in this cleared area an anti personnel mine was blown up and in the result right backside tire of MDU has been damaged.

After the mentioned accident the party rechecked the area located backside of accident point, they have found another PMN-2 missed mine 1 meter back side of the accident point.

But during our investigation when we checked the second found mine by mine detector the depth of mine was about 15 cm, out of 13 cm cleared already. The mine detector did not give signal on the mine. It means that these mines were in depth of about 30 cm. Because more than 13 cm in depth of the area was prepared/cleared by MDU and breaching party already.

The backside right tire of MDU was damaged.

The primary cause of this accident is listed as “Inadequate survey” because the clearance requirement at the site was less than half the actual depth of the mines.

The MDU has repaired back and the tire has been changed and now it is ready for work in the field.

The entire minefield should be prepared by MDU more than 30 cm because the depth of mine is too much.

The Deminers are advised to detect properly MDU prepared area by mine detector.

A refresher training of mine detector is advised for the Deminers of this team.
