DDAS Accident Report

Sub: [National demining agency]/MCT-8 Demining Accident Investigation Report

AMAC HERAT INVESTIGATION ON MINE CLEARANCE ACCIDENT

AT 17th DIVISION-MF-0337, HERAT ON 15TH NOVEMBER 2006

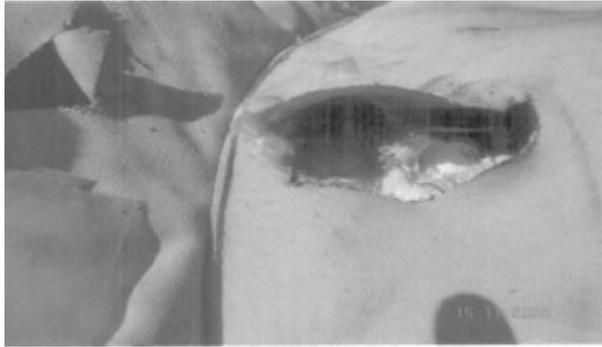
[The picture below shows damage to the body armour. This must have been struck by a sharp edge.]

The crush injury to the Victim's arm and the cut into his body armour were caused by a large object hitting both. The part that hit the armour was sharp. These facts lead to the conclusion that the Victim was using his shovel at the time, as was admitted in one of the statements.
