# DDAS Accident Report

<b>Report date:</b> 26/01/2008	<b>Accident number:</b> 513
<b>Accident time:</b> 08:10	<b>Accident Date:</b> 20/06/2006
<b>Where it occurred:</b> Task # 015 in Kharoti Village, Deh Sabz District, Kabul Province	<b>Country:</b> Afghanistan
<b>Primary cause:</b> Field control inadequacy (?)	<b>Secondary cause:</b> Victim inattention (?)
<b>Class:</b> Excavation accident	<b>Date of main report:</b> 13/07/2006
<b>ID original source:</b> OPS-271338-06	<b>Name of source:</b> UNMACA
<b>Organisation:</b> [Name removed]	
<b>Mine/device:</b> PMN AP blast	<b>Ground condition:</b> ditch/channel/trench dry/dusty grass/grazing area rocks/stones
<b>Date record created:</b>	<b>Date last modified:</b> 26/01/2008
<b>No of victims:</b> 1	<b>No of documents:</b> 2

Subject: Investigation Report

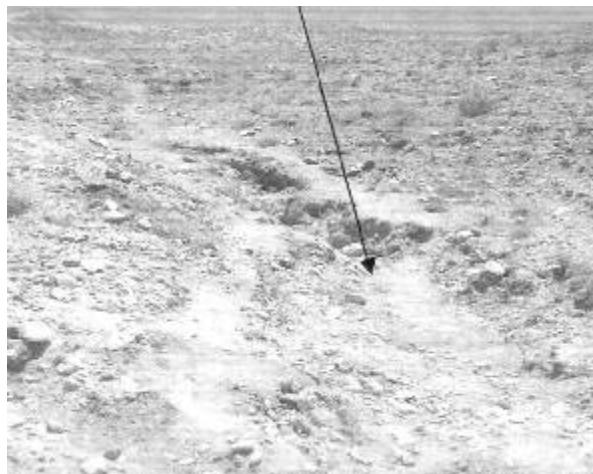
[The accident site (dry ditch) is shown below.]

1- The party was working in a ditch in which sediment soils have been gradually collected by water in the ditch and has covered the ground original surface.

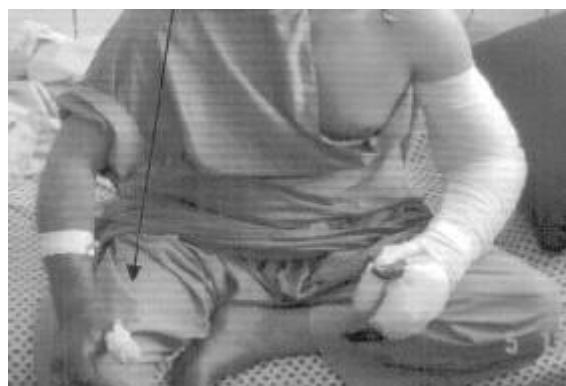
[The Victim suffered injury to] Lower/ Upper part of the left hand.

[The photograph below shows left arm and hand injuries, and a right thumb injury.]

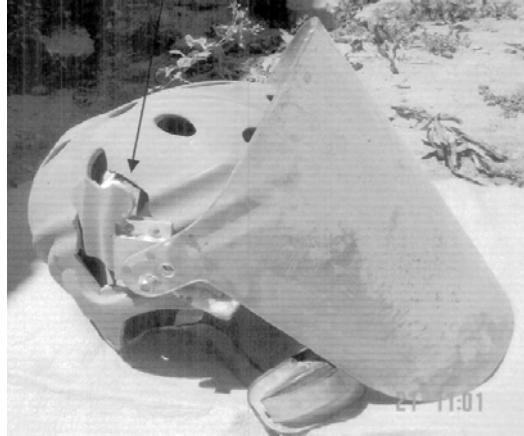
1. Helmet: Right side has been broken, down and the left side has got cracked down.
2. Prodder: According to the team leader the prodder is completely damaged but the investigation team could not find any pieces of the prodder.

[The cracked helmet is shown below. The helmet offers no protection: it merely holds the visor.]

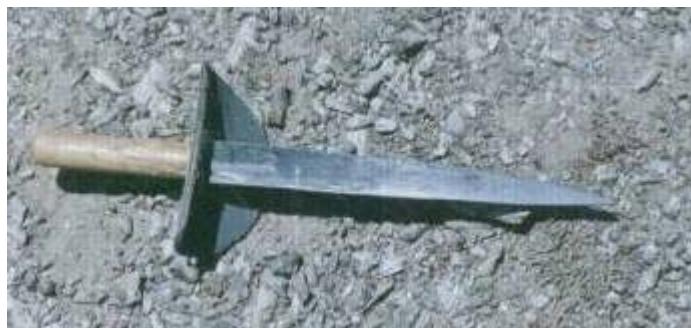
The Victim was right handed and the left hand suffered most of the injury. The locally made "bayonet" in use is shown below. It has a rubber hand-guard made from the side-wall of a vehicle tyre, and its blade is much longer than the standard AK bayonet frequently used. It seems likely that the Victim was using his left hand on top of the rubber guard when the accident occurred. In hard ground, excavating one-handed with a tool like this can be unrealistic.
