DDAS Accident Report

Report date: 29/01/2008	Accident number: 532
Accident time: Not recorded	Accident Date: 15/08/2004
Where it occurred: MF011, Salahley Municipality, Nr Ina Guuxaa, Salahley District, Galbeed Province	Country: Somaliland
Primary cause: Unavoidable (?)	Secondary cause: Unavoidable (?)
Class: Excavation accident	Date of main report: 15/08/2004
ID original source: None	Name of source: [Name removed]
Organisation: [Name removed]	
Mine/device: P2Mk2 P4Mk1 AP blast	Ground condition: dry/dusty grass/grazing area hard
Date record created:	Date last modified: 29/01/2008
No of victims: 1	No of documents: 1

SUBJECT: Mine Accident

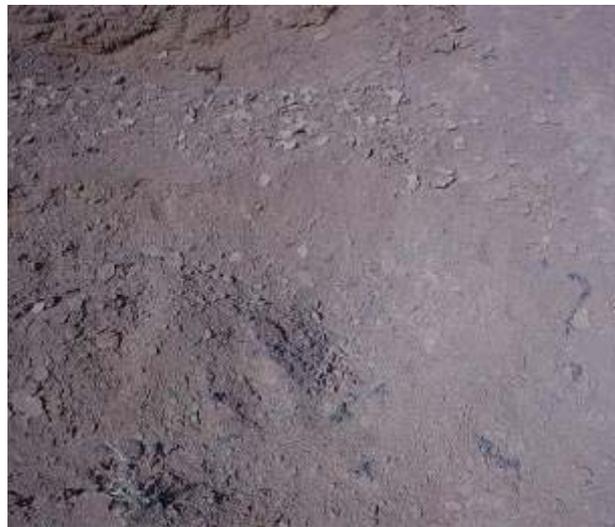
[The point of initiation.]

Our second and most likely conclusion is that the mine may have been laid at a 45% angle in which case when the deminer pulls the rake towards himself the mine would detonate.

There is no definite explanation for how the accident has happened but due to what we do know the decision has been that all deminers will go through further correctional training under the supervision of [Name removed] and myself.

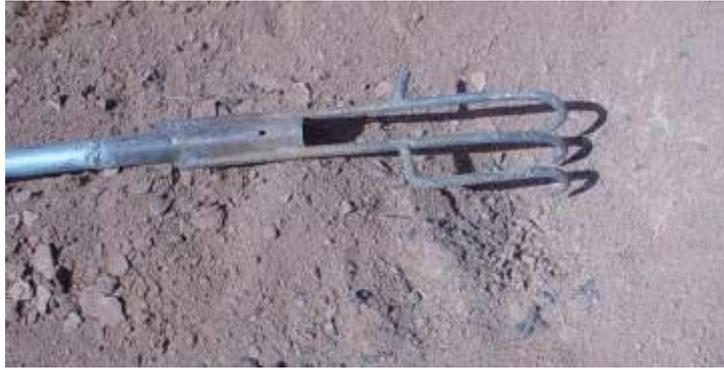
[The rake head with one tine broken off is shown above. This demining group uses a four tine rake that some have criticised as being more likely to initiate mines than the two tine rake because it requires more force to pull it through the ground.]

Deminer [the Victim] was carrying out rake clearance on lane A1, Box 2. [He] explained that the mine detonated whilst he was pulling the rake back towards himself. There were no Injuries to [the Victim] or his protection equipment but the rake received minor damage. Through the investigation we came to the conclusion that the position of the mine was at an angle.

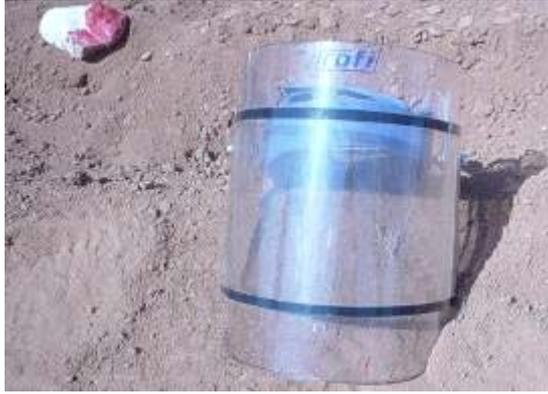
[The Victim's visor after the blast was unmarked.]

The demining group had put in place the use of a long tool (rake) that kept the Victim far enough away from a blast to avoid injury, and his PPE was effective at protecting him from any risk remaining at that distance. Had he been using conventional short hand-tools, some injury would have been expected.
