DDAS Accident Report

Report date: 29/01/2008	Accident number: 534
Accident time: Not recorded	Accident Date: 25/08/2005
Where it occurred: MF 14, Duruqsi Municipality, Nr Bisqua, Duruqsi District, Togdheer Province.	Country: Somaliland
Primary cause: Unavoidable (?)	Secondary cause: Unavoidable (?)
Class: Excavation accident	Date of main report: 26/08/2005
ID original source: None	Name of source: [Name removed]
Organisation: [Name removed]	
Mine/device: P2Mk2 P4Mk1 AP blast	Ground condition: bushes/scrub hidden root mat soft
Date record created:	Date last modified: 29/01/2008
No of victims: 1	No of documents: 1

The incident occurred whilst Deminer [the Victim] was carrying out clearance using the raking method in Lane 9, MF 14, Bisqua.

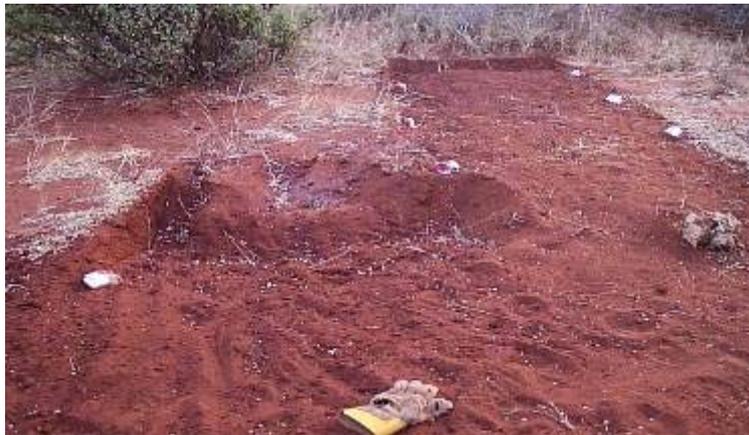
The Investigation team came to the conclusion that the AP mine was disturbed previously by the roots of a tree which is situated approximately 1 meter away from the point of detonation.

The root can clearly be seen by the investigators at the point of where the detonation occurred and it is believed the AP mine was tilted away from the Deminer as he was raking.

[The Victim's lane is shown above.]

The Investigation team decided to do a day's training under their supervision before the deminers could commence work.

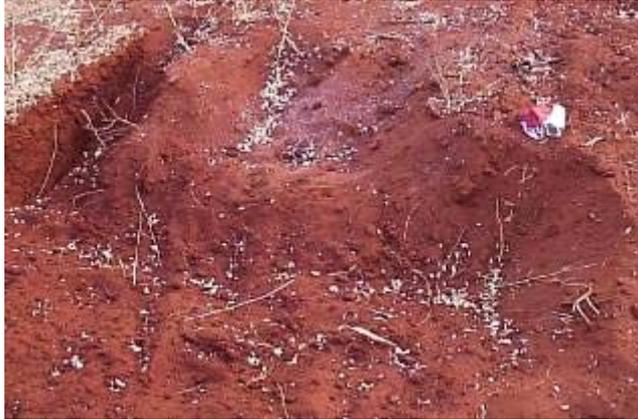
[Roots shown in a close-up are very thin.]

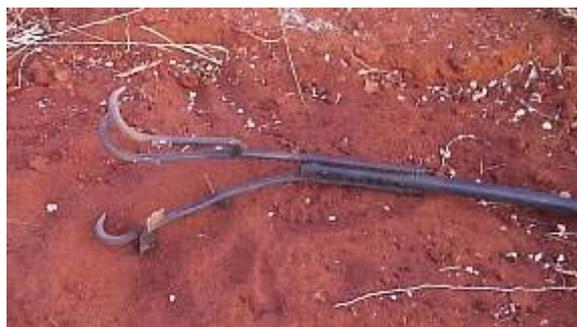
There were no injuries to the Deminer although the rake itself was damaged by the impact.

[The victim's four tine rake head is shown above. Its damage from such a small mine is significant when compared to the damage seen with two tine rakes with the same or larger mines. The risk of parts breaking away and hitting the deminer is real. Some also think that the four tine rake favoured by this demining group is more likely to initiate mines because of the additional force needed to drag it through the ground.]

It is possible that the roots were being broken by simply tugging the rake head (a common practice) and that this caused the accident. Excess force may be more likely to be necessary with a four tine rake than with a two tine rake.
