DDAS Accident Report

SUBJECT: BOARD OF INQUIRY REPORT

FOR [Demining group] UXO ACCIDENT IN AR RAFIYAH DISTRICT, SOUTHERN IRAQ, 09 January 2007

DATE: 12 January 2007

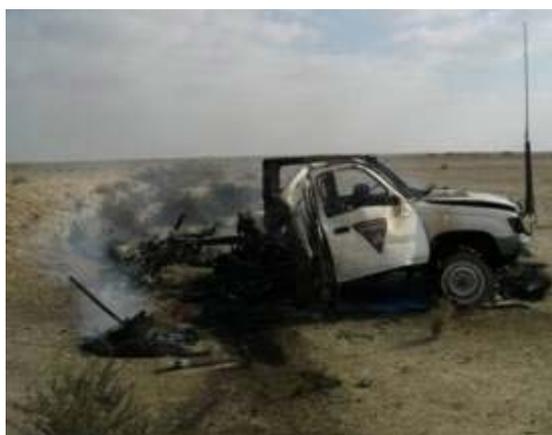
8.2 The vehicle (Toyota Hilux) had been destroyed by the effects of both explosive detonation(s) and a subsequent fire. The cab's roof was found 50 metres SW of the vehicle on a bearing of 188°.

[One side of the pick-up, showing how the load bay (bed) has been destroyed.]

8.3 The bed of the vehicle was gone. Parts of the side panels were found as far as 100 metres from the vehicle.

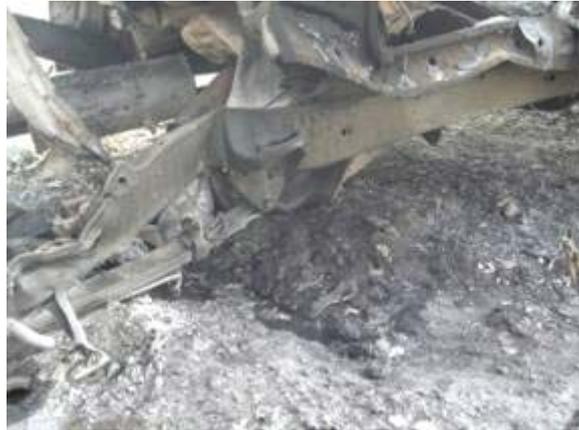
8.4 [Victim No.1]'s remains lay on the driver's side of the vehicle close to the left rear wheel. The vehicle tailgate and part of the vehicle bed had been blown off and was covering the body. The part of the vehicle bed covering the remains was missing a section in the area corresponding to that directly behind the right corner of the cab and forward of the right rear wheel. The section of frame brace directly beneath this location had been cut, the ends indicating a detonation from above. Beneath this section was found a crater 56 cm in diameter and 9 cm deep. This also indicated a detonation from the same locality.

[The crater and damaged chassis of the vehicle.]
