DDAS Accident Report

Report date: 01/02/2008	Accident number: 544
Accident time: 12:00	Accident Date: 02/03/2004
Where it occurred: Ward 18, Dehsabz, Kabul Province	Country: Afghanistan
Primary cause: Inadequate training (?)	Secondary cause: Field control inadequacy (?)
Class: Handling accident	Date of main report: Not recorded
ID original source: None	Name of source: [Name removed]
Organisation: [Name removed]	
Mine/device: Flare/ Ordnance	Ground condition: demolition site (explosives) dry/dusty rocks/stones
Date record created:	Date last modified: 01/02/2008
No of victims: 2	No of documents: 1

ACCIDENT REPORT

[Demining group], KABUL SEPTEMBER 2003

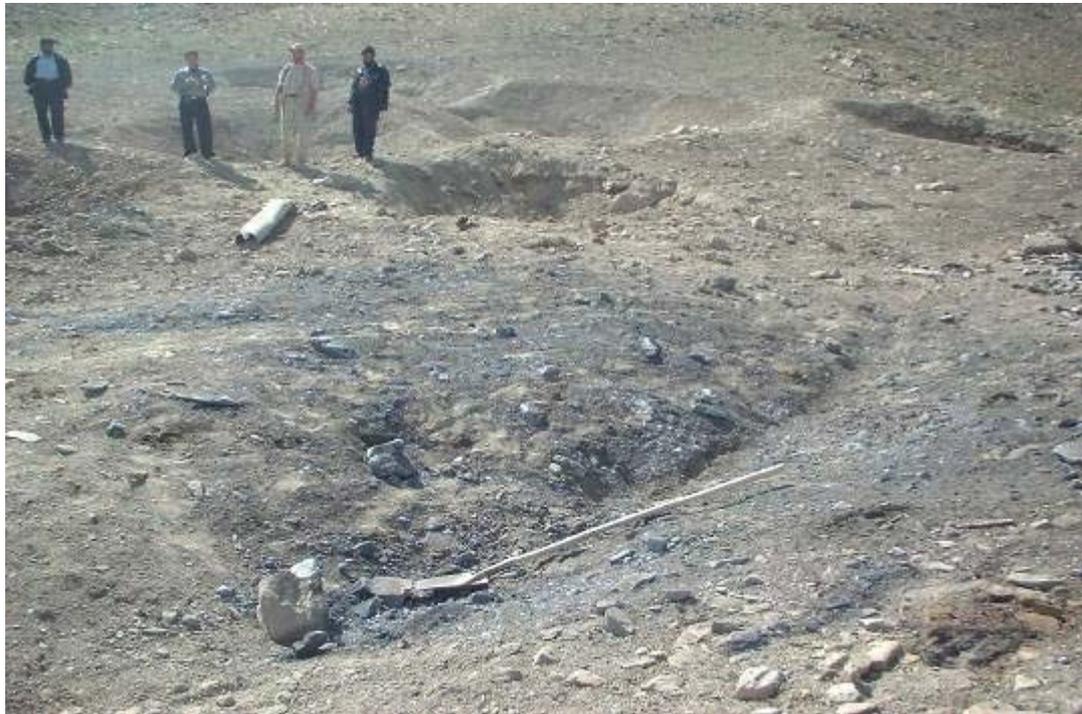
Based on the findings of investigation team from the accident point and shrapnel taken out from the wounds of the deminer, a flare has got fire and caused the injuries.

The Victims were working without PPE. This is presumed because of the injuries received and the fact that their uniforms were damaged but no PPE was damaged. The photograph of the investigation showed men without PPE. It may be that the demining group performed BAC and ordnance disposal tasks without wearing PPE, and that this was approved by the National Authority. However, given that most UXO accidents involve fuzes, it would always be worth wearing PPE.

As the flare was kicked out from the demolition and the possibility of risk was still in place therefore, the deminers should not touch the kicked out UXO without the permission of team or section leader. And also they must keep the specific distance between each other while doing BAC after the demolition.
