# DDAS Accident Report

<b>Report date:</b> 04/02/2008	<b>Accident number:</b> 550
<b>Accident time:</b> 10:30	<b>Accident Date:</b> 24/07/2006
<b>Where it occurred:</b> Task # 663-E-06, Kandahar Air Field, Dand District, Kandahar province	<b>Country:</b> Afghanistan
<b>Primary cause:</b> Field control inadequacy (?)	<b>Secondary cause:</b> Inadequate equipment (?)
<b>Class:</b> Excavation accident	<b>Date of main report:</b> 02/08/2006
<b>ID original source:</b> OPS/03/01-12	<b>Name of source:</b> UNMACA
<b>Organisation:</b> [Name removed]	
<b>Mine/device:</b> PMN AP blast	<b>Ground condition:</b> dry/dusty hard
<b>Date record created:</b>	<b>Date last modified:</b> 04/02/2008
<b>No of victims:</b> 1	<b>No of documents:</b> 2

Sub: Demining Accident Initial Investigation Report

## Investigation Report of Mine/UXO Accident/Incident

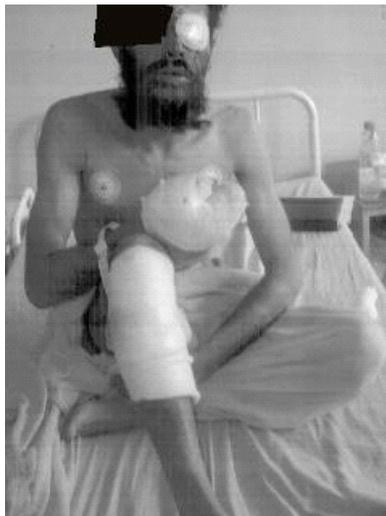
Eyesight damage both eyes: head/Neck above lips. Upper limbs. Lower limbs.

A sketch showed injured lacerations on face and eyes. Injured on right hand. Injured below right knee.

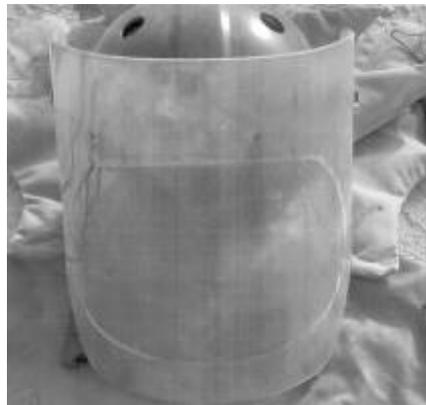
The primary cause of this accident is listed as a “Field control inadequacy” because the Victim was working with his Visor raised and his error was not corrected.

Note: In a blast event, there is nothing to raise the visor until the fragments strike, closely followed by the blast wave. A loose visor in a down position is often torn off by the passage of the blast-wave, but it could not be raised before the fragments struck. In this case, the deminers were inventing an impossible phenomenon as an excuse because they had been told that the Victim would not get his insurance if he was at fault. That the deminers had been frightened with this kind of threat illustrates a significant “Management control inadequacy” that has often been tried by demining groups, and is always quickly dropped. The deminer with a raised visor is, by definition, being poorly supervised, so is not the only one at fault.

In this case, the deminer may have raised his visor because it was in poor condition and hard to see through (some visors needed to be replaced). A picture of the Visor is shown below. Whether it sustained any damage in the accident is unknown, but the visor shown would be hard to see through.

V. The [International demining company] is recommended to provide helmets to their teams with locking visors.

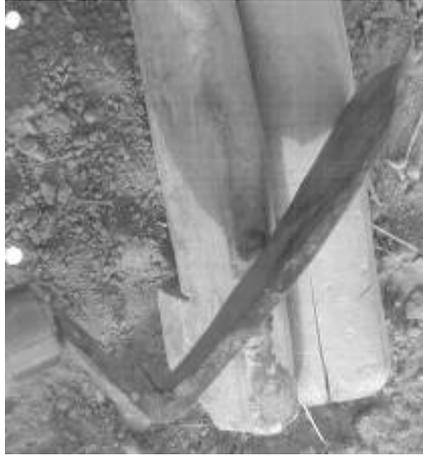
Answer No 2: While I was excavating with a small shovel (Rumbay more like an Adze).

The secondary cause is listed as inadequate equipment because the Victim’s hand tool was bizarrely inappropriate, and neither designed for purpose nor blast-resistant. A picture is shown below.
