DDAS Accident Report

Report date: 04/02/2008	Accident number: 551
Accident time: 10:48	Accident Date: 24/05/2006
Where it occurred: Task # 099, Ashrafkhail village. Bagram District, Parwan Province	Country: Afghanistan
Primary cause: Management/control inadequacy (?)	Secondary cause: Field control inadequacy (?)
Class: Excavation accident	Date of main report: 24/08/2006
ID original source: OPS-27/290-06	Name of source: UNMACA
Organisation: [Name removed]	
Mine/device: PMN-2 AP blast	Ground condition: dry/dusty rocks/stones
Date record created:	Date last modified: 04/02/2008
No of victims: 1	No of documents: 2

Demining Investigation Report

Device that caused the incident/accident: PMN-2 AP blast

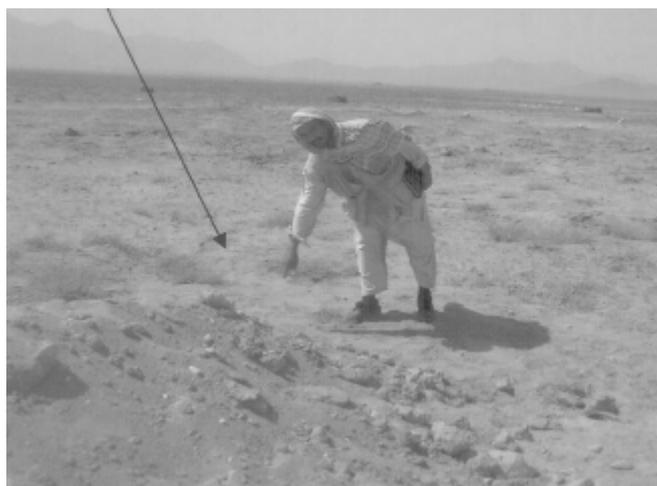
Site conditions: The terrain was open and flat. The soil was soft and dry. The weather was clear, calm and mild. There was no vegetation.

[The accident site.]
