DDAS Accident Report

Report date: 05/02/2008	Accident number: 553
Accident time: 10:08	Accident Date: 19/01/2007
Where it occurred: CBU Site No: 483, Nr Al Smaaiyeh Village, Tyre District	Country: Lebanon
Primary cause: Victim inattention (?)	Secondary cause: Inadequate survey (?)
Class: Excavation accident	Date of main report: 02/02/2007
ID original source: No 001/2007	Name of source: UNMAS
Organisation: [Name removed]	
Mine/device: DPICM M77 submunition	Ground condition: agricultural (recent) bushes/scrub leaf litter residential/urban soft trees
Date record created:	Date last modified: 05/02/2008
No of victims: 2	No of documents: 2

REPORT FOR ACCIDENT INVESTIGATION

BAC Accident that occurred in Area 7-004 (CBU 834), UTM 707747/3677539 on 19th January 2007 in which [Demining group] BAC Team Leader [Name removed] was injured.

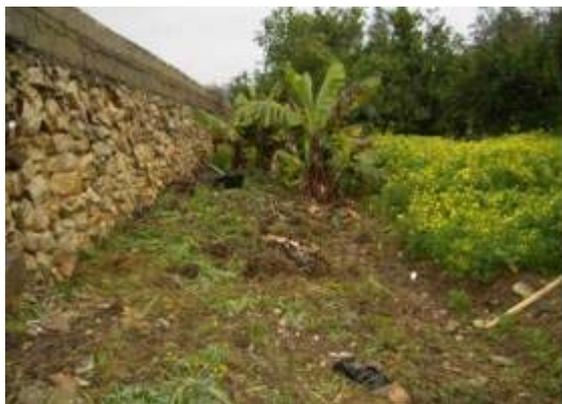
[The accident site.]

9. At approximately 1008hrs, an uncontrolled explosion occurred in box C3, involving [the Victim]. At the time of the accident all team members were wearing PPE (jacket and visor).

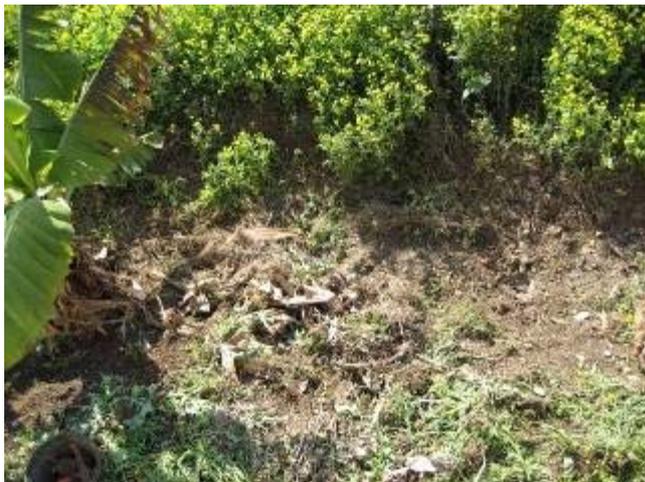
Location of the Accident

The area of the detonation was located to the rear of the area where visual search operations were being conducted.

The accident occurred in box C3.

[The left of the picture is the area in which the three searchers were conducting visual search clearance to the front of the team supervisor.]

The area was to the rear of the area currently being visually searched by the three searches to his front.

The three searchers most likely missed the sign or signs indicating the presence of the M77.

Revise all searches on BAC surface search/clearance drills.

Greater attention and constant supervision, by team leaders when conducting both visual and sub-surface clearance in areas where there are soft ground conditions.

Clearance plans must reflect areas, which have soft ground conditions, with a possible risk for sub-surface sub-munitions have to be identified at an early stage before, commence of the clearance process.

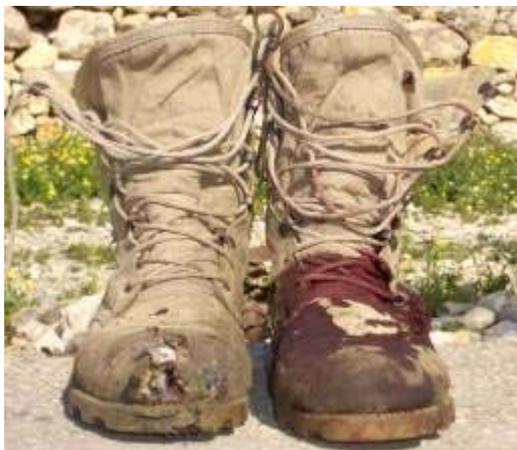
[The Victim's boots are shown below.]

The toe of the right boot confirms the contact point to the M77.

Damage to both the left and right boots was confirmed.

[The damaged area on the toe of the right boot where it made contact with the M77 is visible. There was no damage to the sole of boot. Metal fragments entered the right side of the left boot and exited through the right side.]

- c. The damage to the right boot reveals no damage to the sole. The boot has a large fragment embedded in the toe section. The left boot shows signs of fragmentation but is otherwise undamaged.

- f. The victim, in the investigators opinion, probably investigated the ground and/or sub munition with his right boot toe cap.

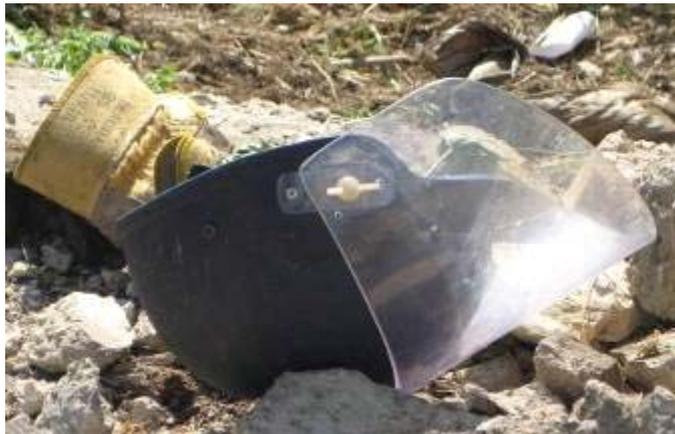
[The Victim's visor.]

15. At the time of the accident, the searchers and Team Leader were wearing protective vest, helmet and visor.

From the evidence gathered, it can be established that [the Victim] was wearing his PPE correctly at the time of detonation.

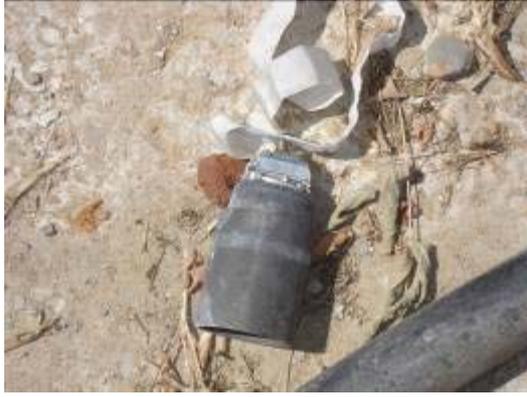
US M-77

26. The M77 HE cluster bomb is commonly referred to among the Lebanese and Palestinian population as the "battery bomb" or "lighter" bomb because of its shape. There M77 HE grenades are dispensed from various sizes of projectiles, which are initiated by mechanical time fuses above the target areas to allow dispersion of the grenade. The M77 has a white nylon ribbon which when pulled or touched can detonate. Shortly after ejection from the projectile, artillery shell or various size of container or dispenser, the M77 HE grenade arms due to the rotation of the white nylon ribbon. This ribbon also acts as stabilizing tail to orient the cone of the grenade towards the target. Upon impact a charge in the grenade launched downward to penetrate armour while the metal grenade body bursts into shrapnel-like fragments to wound and kill personnel. The M77 has a white band around its body.
