DDAS Accident Report

Sub: DEMINING ACCIDENT INVESTIGATION REPORT

Investigation Report of Mine/UXO Accident/Incident

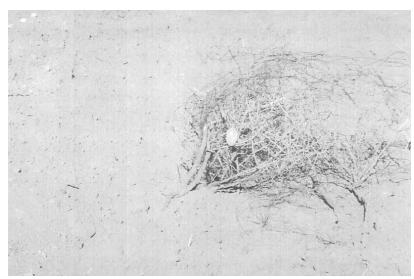
During the excavating of soil, which prepared (removed soil during the preparation by backhoe) by backhoe the mine was setoff. The deminer has pulled the bushes which were removed by Backhoe from the actual place and the visible wires were connected to the bushes it could be trip wires but the deminer has pulled it carelessly the accident has occurred.)

Supervision: The section leader, ATL and team leader did not closely monitor the deminer during excavation on the backhoe's prepared soil (seems Deminer was not wearing full PPE and was working in an unapproved prodding position).

Careless[ness] of victim: Deminer has not operated in approved prodding/excavation position (injuries to his left shoulder shows working in a side position). The Deminer has not worn full PPE with apron (as he has got injuries to his thigh).

[Over-exposed and photocopied pictures showed long apron PPE with small blood spots (implying that it was worn), a small thumb, index and forefinger injury on the left hand, a small fragment in the inner thigh, 15cm above the knee, a small injury inside the left forearm and a small fragment on the left shoulder (which would have been exposed if the deminer had been side-on to the detonation. The accident site is shown below.]

- 1. The command group of the team have obligation to control and guide their subordinates (deminers) during field operations especially while they are doing prodding, excavation and pulling.
- 2. Deminer should fully brief his successor during each change process about the specifications of each area (clearance Lane) and they should consult each other regularly.
- 3. Deminers are to wear full PPE while entering to operational area.
- 4. All deminers are to work on a signal with an approved position.
- 5. The deminer should never touch and pull bushes and any suspected wires without instruction of command group (immediate supervisor).
- 6. A refresher training with a focus on prodding, excavation, pulling and use of PPE should be provided to the team members.
