DDAS Accident Report

CII BAFSR 29/05/2006

FINAL INCIDENT REPORT

BAF SOUTHERN RUNWAY, BAGRAM

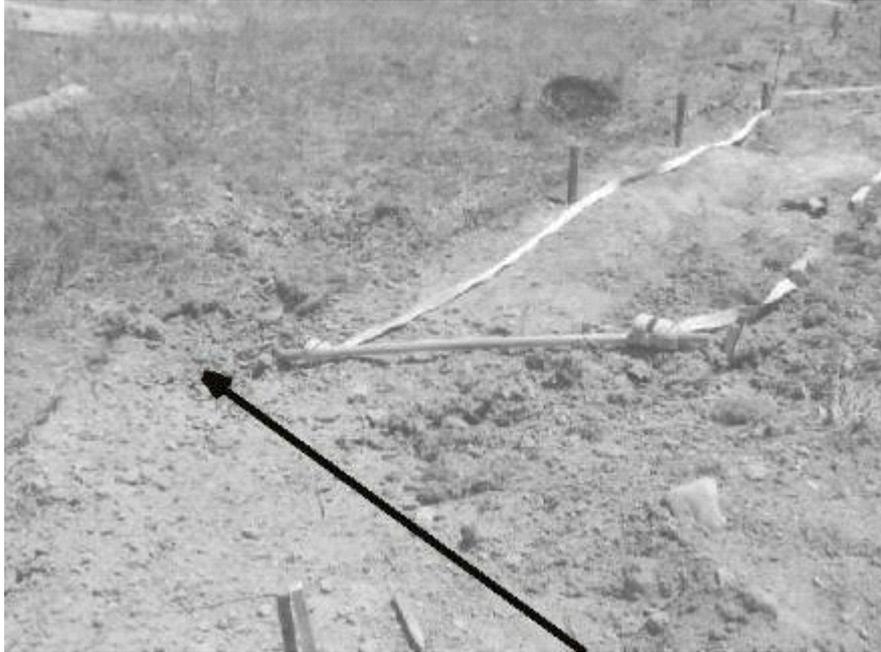
Responsible device was suspected to as being a PMN located in a 2nd mine line.

[The accident site is indicated below. The arrow indicates the site of the initiation, which would have been well within reach of a deminer kneeling at the base-stick.]

The mine does NOT appear to have been within the deminer's lane or to the right of his operating position and so the conclusion is that this was not activated by touch.

The PMN is activated by a cock-strike principle; excessive vibrations will cause this mine to activate.

- Age deterioration- buried for approximately 12 years in harsh climates.
- Detonation of other mines within close proximity — controlled detonation by BAF EOD 26th May 2006.

1. Discussions should be held between BAF MAC, BAF EOD., and [International demining company] with regard to further in-situ demolitions when required.
2. Where demolitions are to be carried out in situ by BAF EOD, any mines that have failed to detonate must be clearly identified by BAF EOD and marked with a 25m safety distance by [International demining company]. An agreement should be sought between USMAC, BAF EOD and [International demining company] of how best to dispose of items that have failed to detonate.
3. Periodic practice emergency drills are to be strictly continued.
4. The correct and constant use of PPE in all areas is once again to be emphasized as the injuries in this case are mitigated to a large extent by the correct usage of PPE.
