# DDAS Accident Report

## INDEPENDENT INVESTIGATION REPORT 011/07

FOR [International commercial company] DEMINING INCIDENT  
AT TASK CBU- 771 2nd July 2007

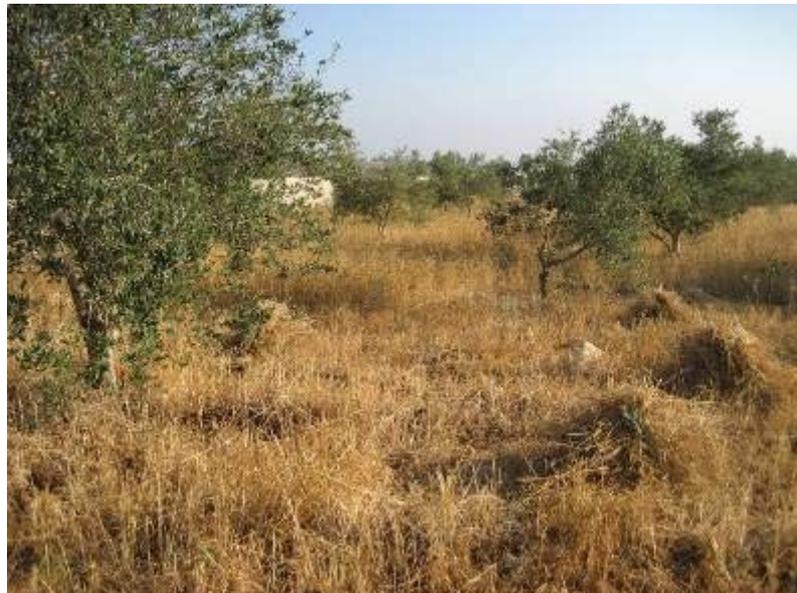
### **Evidence**

[The accident site is shown above.]

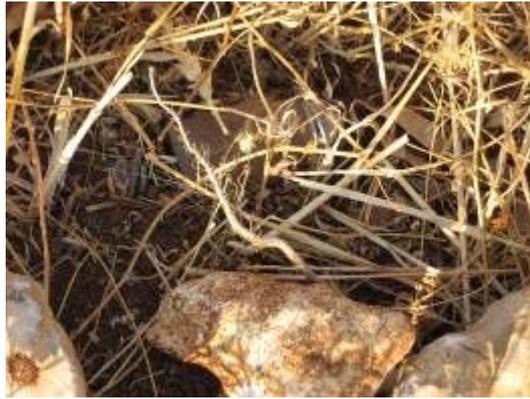
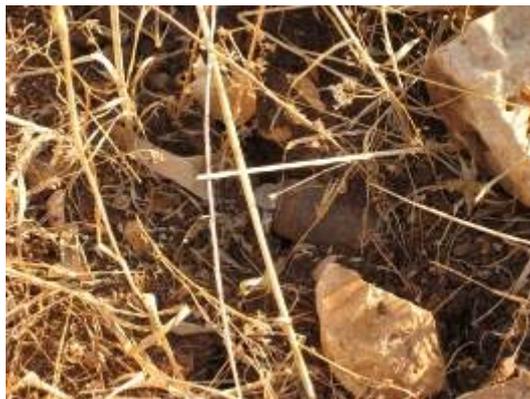
The items had not been removed; the location had been marked with pickets and stones. The items were clearly visible on the surface but would be difficult to see but not detect during sub surface clearance. The area where the items were located was identified and confirmed as part of the CBU that had been cleared sub surface. The items were situated in the middle of the area cleared sub surface approx. 10-15m apart.

[The munitions are shown above – easy to locate with any metal-detector search.]

The area was not cleared sub-surface in accordance with the [International commercial company] SOPs or the NTSGs.

c. The area in question is to be re-cleared using the appropriate sub-surface clearance procedures, in accordance with [International commercial company] SOPs and the NTSGs, until fade or the MACC Ops Officer confirms not additional clearance is required in this site.
