DDAS Accident Report

REPORT FOR ACCIDENT INVESTIGATION BOARD OF INQUIRY – No 005/2007

BAC Accident that occurred in Area 7- 008 (CBU 071), UTM 728309/3676516 on the 21st June 2007 in which a searcher was injured.

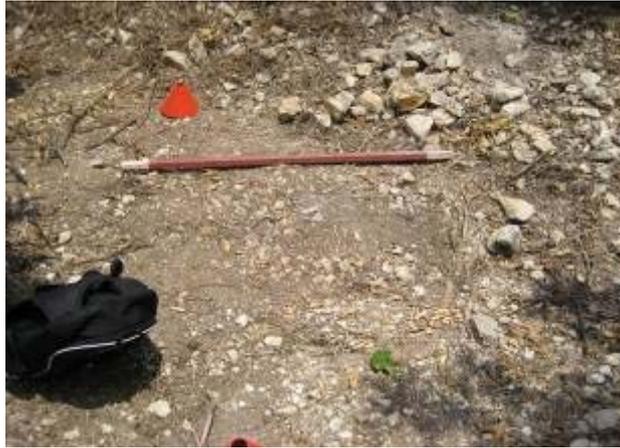
- There had been an uncontrolled detonation of an M42 Sub-munitions,
- The M42 was either partially or completely buried,
- The area of the detonation was at least 1m forward of the base stick, in an uncleared area.

[The crater is top right, the red cone is the marking system in use.]

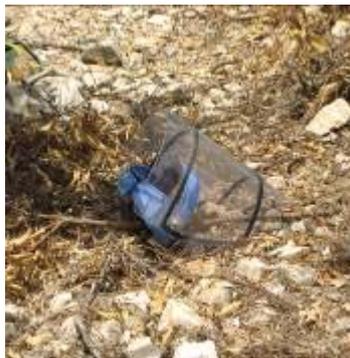
[The undamaged visor approximately 9 metres away.]

The visor was laying in good order on 9 meters distance from RP, indicating that the searcher or other person has intentionally put the visor down on the ground without to prevent getting scratch marks.

The Visor position could indicate that the searcher has taken the visor off inside the hazard area during work time. If so, this is a major safety violation and not follows the [Demining group] SOP.

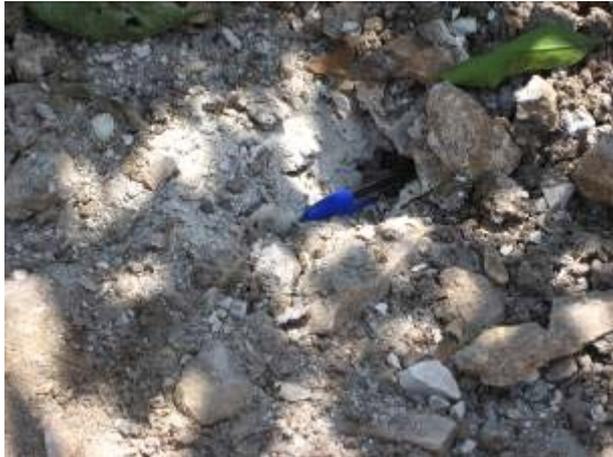
- b) An uncontrolled detonation occurred in an area where the earth had been gathered to provide a bund around citrus trees to retain water for irrigation.

[There was no earth in photographs, but stones – and no obvious “bund”. This picture shows a pen at the seat of detonation.]

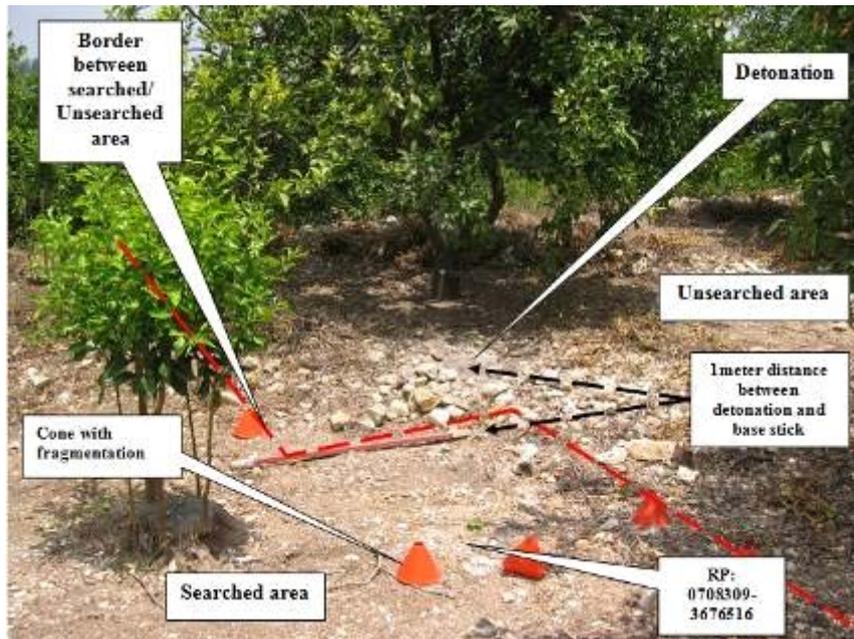
Picture 1.

The border of searched/not searched areas was well marked. The location of detonation was 1 meter in front of ongoing search, in not searched area. One cone was lying flipped over and was most likely moved by air pressure. One cone is penetrated of several fragmentations.
