DDAS Accident Report

Report date: 16/03/2011	Accident number: 586
Accident time: 05:55	Accident Date: 23/11/2002
Where it occurred: Task No.116, Kamchewai, Northern Red Sea Zone	Country: Eritrea
Primary cause: Inadequate training (?)	Secondary cause: Management/control inadequacy (?)
Class: Missed-mine accident	Date of main report: 07/12/2002
ID original source: AM HT	Name of source: MACC Eritrea
Organisation: [Name removed]	
Mine/device: AT (unrecorded)	Ground condition: dry/dusty grass/grazing area
Date record created:	Date last modified: 23/08/2010
No of victims: 8	No of documents: 3

FATAL INCIDENT REPORT, DEMINING INCIDENT AT KAMCHEWAY 23 NOVEMBER 2002 - AN ANTI TANK (AT) MINE MISSED BY THE MINE DETECTION DOG (MDD) TEAM

Demining Incident Preliminary Investigation Report for Submission to the Director of the [Demining group] and the Eritrean Demining Authority

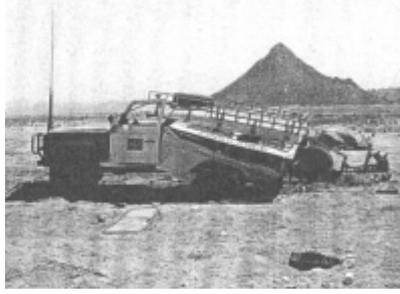
The team then entered the minefield from the access route and along the main breach lane passing Administration/parking areas 1 and 2. It was evident from area 1 that the accident had occurred in a cleared area.

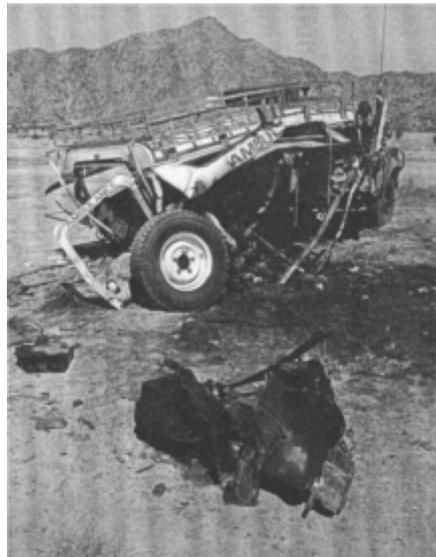
After studying the minefield maps which had been carried to, and retrieved from the scene it was possible to identify that the detonation had taken place within an area cleared by Manual deminers and Mine Detection Dogs (MDDs).

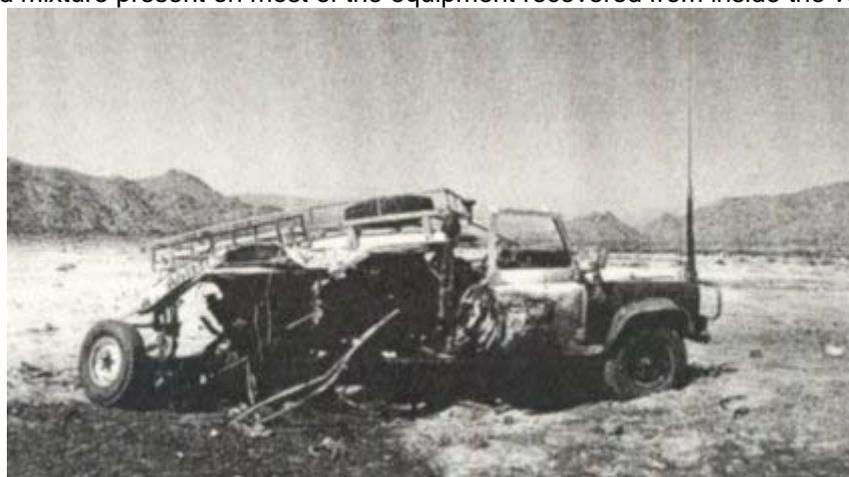
Damage to Vehicle and Equipment

The rear right wheel of the Landrover 110 Ambulance detonated the AT mine. The vehicle was thrown through 180° coming to rest facing back in the direction it had come. The rear right wheel was completely destroyed, the axle had been forced upwards through an angle of more than 45°, the floor of the rear of the vehicle had been forced through a similar angle. The entire right hand side of the vehicle from the back door to the cab had been destroyed. The vehicle had buckled approx. midway along the chassis causing the roof above the cab to fold up and back. Team equipment such as detectors, tool bags, and marking rope reels that were being carried on the roof of the vehicle were thrown clear. The trauma bag (used by the medic at the scene) was recovered intact from the rear of the vehicle. Vests and visors removed from the interior of the vehicle were covered in a mixture of diesel and mud, some of the visors had broken headbands and fogged fronts. The demolition exploder case had been partially damaged and the exploder itself had shattered. The detonator boxes carried inside the detonator compartment built into the rear left frame of the vehicle (situated under the rear most seat on the left) were undamaged as was the compartment itself. The explosives box carried inside the rear of the vehicle was dented but otherwise intact. The second stretcher (orange, vinyl) also carried inside the vehicle was badly damaged and coated in the same diesel, mud mixture present on most of the equipment recovered from inside the vehicle.
