DDAS Accident Report

Report date: 05/03/2011	Accident number: 617
Accident time: 08:37	Accident Date: 05/01/2009
Where it occurred: MF No: E 397 SABHA 6, Um Al Quttain Village, Almafraq Province	Country: Jordan
Primary cause: Unavoidable (?)	Secondary cause: Unavoidable (?)
Class: Excavation accident	Date of main report: Not recorded
ID original source: None	Name of source: Demining group
Organisation: [Name removed]	
Mine/device: M14 AP blast	Ground condition: hard rocks/stones
Date record created:	Date last modified: 05/03/2011
No of victims: 1	No of documents: 2

INCIDENT INVESTIGATION FOR [Demining group] – MINE ACTION TEAM - JORDAN

MINEFIELD NO – 397, MINEFIELD TASK ID - E 397 SABHA 6

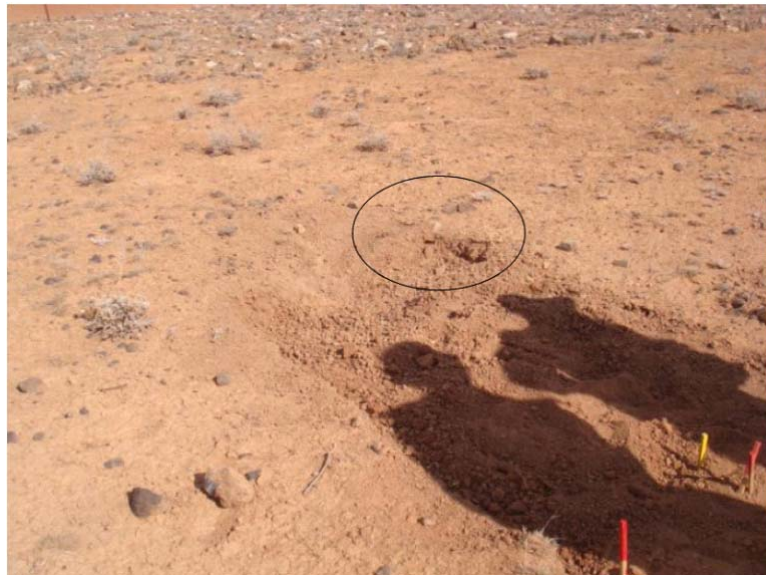
While the deminer trying to recover an AP m14 mine using the heavy RAKE he applied a pressure in the pressure palate of a non visible M14 which in turn activated that mine in a depth of about 5-7 cm

Crater Depth: approx. 15 cm / Width: approx. 40 cm

[The accident site.]

According to the preliminary investigation the incident is caused due to a pressure applied to the mine from the heavy RAKE (the excavation tool) used by the deminer and the deminer didn't expect to find a mine in that spot with that depth and may like accident could be avoided by using the metal detector to locate the non visible mine before using the standard RAKE drill.
