DDAS Accident Report

Report date: 05/03/2011	Accident number: 628
Accident time: 09:24	Accident Date: 07/09/2009
Where it occurred: MF: E 387 Al Shajarah Village, Alramtha Province	Country: Jordan
Primary cause: Victim inattention (?)	Secondary cause: Management/control inadequacy (?)
Class: Missed-mine accident	Date of main report: Not recorded
ID original source: None	Name of source: Demining group
Organisation: [Name removed]	
Mine/device: M14 AP blast	Ground condition: grass/grazing area hard
Date record created:	Date last modified: 05/03/2011
No of victims: 1	No of documents: 2

INCIDENT INVESTIGATION [Demining group] – MINE ACTION TEAM - JORDAN

TASK NAME AL SHAJARAH 1 (387)

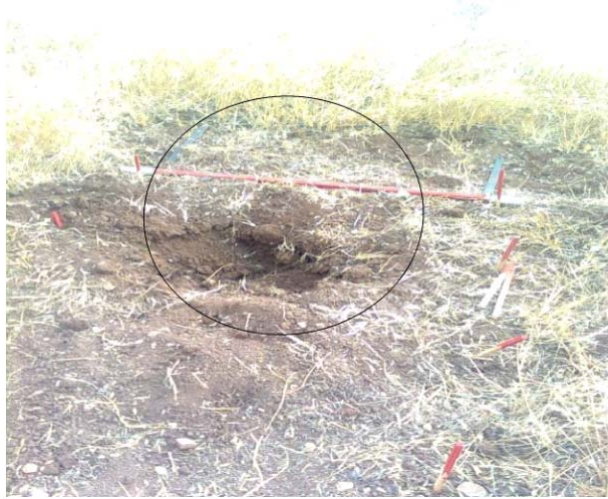
Deminer was clearing the first 60 cm of one cluster heading toward the centre mine after he cleared the 1st 60 cm by one 1m width with no signals he moved his base stick a head to clear the next 60 cm, then he stepped on the area which considered to be cleared by the same deminer, accidentally his foot went down due to the soil collapse under his foot (loose soil), the mine was in a depth of about 30 cm that when the deminer foot dived in the loosen soil he applied a pressure on the mine which activated the mine and caused the accident, note that from the accident result there was no direct contact between the deminer foot and the mine.

[The accident site, behind the base-stick in the area considered "cleared" by the deminer.]

Deminer was applying the drill as per as sop without any mistakes, he stepped on a loose soil area after he cleared it by the metal detector and investigated all the signals, the soil under his foot collapsed and caused the deminer foot to went down inside the loosen soil and activated the mine which was not exactly in its right place..

This accident is classed as a *Missed mine accident* because the photograph showed that the site of the initiation was behind the base-stick and between the side of lane markings – so in an area that the deminer had “cleared”.

The primary cause of this accident is listed as *Victim inattention* because the Victim had not located the mines when using his detector and had not used the demining group's excavation/detector drill appropriately enough to find a mine at this depth. (This drill is designed to locate mines that are too deep for the detector to locate without removing some of the ground. The ground he stepped on had been loosened, but had not been removed and searched with the detector appropriately.) The secondary cause is listed as a *Management Control Inadequacy* because the investigator concluded that no mistakes had been made, when clearly some had. If management does not recognise an error, it will not be corrected. The investigator's failure to check the performance of the metal detector was unusual and appears to have been an oversight.
