DDAS Accident Report

MINE INCIDENT REPORT 006/2007

Report on Incident that occurred on the 28th and 29th March 2007 in Minefield 1580 Kfar Houne.

INVESTIGATION REPORT ON TWO MISSED MINES AT MINEFIELD 1580, KFAR HOUNE [Confusingly, this report gives details of three mines, one of which was visible but outside the cleared area.]

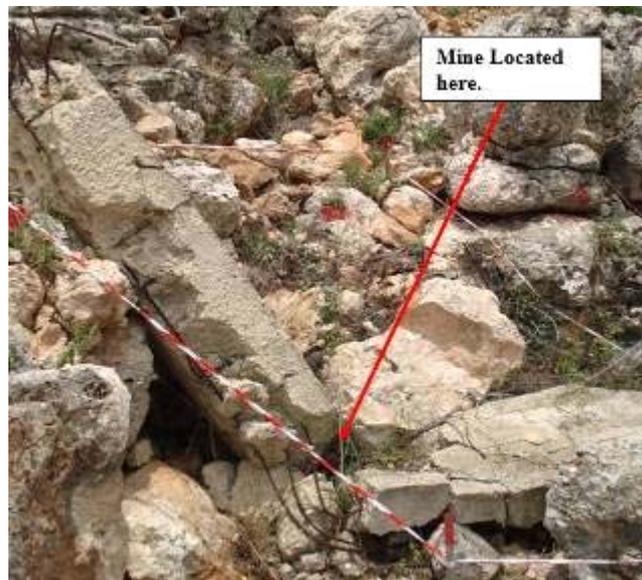
[Demining group 2] SL deployed several MCTs to the Sowaida position to remove the wire which had been left on the site by other clearance contractors, during the clearance of this wire one of the supervisors spotted the remains of an Israeli number 4 AP mine wedged into a large concrete beam which lay within an un-cleared area on the eastern side of the position. This was reported to [Demining group 2] SL Area 6 Operations Manager.

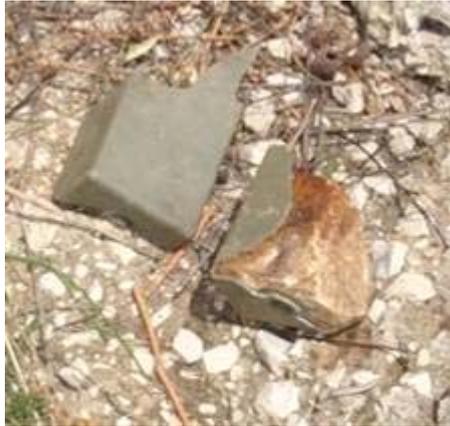
- The remains of the mine were un-fused.
- The mine case was broken where and the explosive content joins the fuse well.

- The rear of the mine case was open and some of the TNT fill was not present at the rear of the mine, the exposed TNT had been subjected to weathering and the TNT was black [brown], which would indicate that it has been exposed to the environment for an extended period of time.
- The forward edge of the mine had been shielded from the weather and the fuse well threads were undamaged which would indicate that the fuse had been removed rather than blown out by a detonation.
- Striation marks were visible on the plastic case of the mine which would indicate a blast had taken place at the rear of the mine.

As this site has yet to be handed over it is recommended that the completion paperwork be made available to confirm that the remains of the mine were in an un-cleared area.

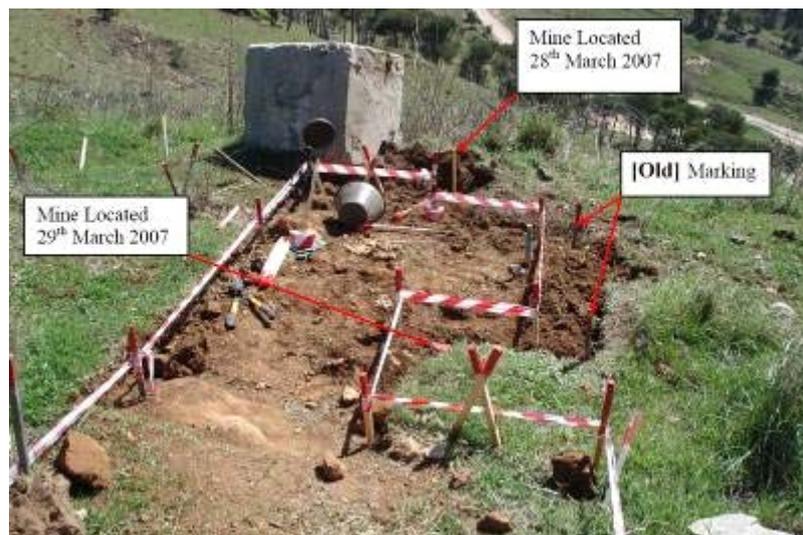
3. During clearance operations 28th March 2007 one Israeli Number 4A AP mine was located 4cm inside the [Demining group 1] clearance lane.
4. During clearance operations 29th March 2007 a further Israeli Number 4A AP mine was located in the marked and cleared [Demining group 1] clearance lane, this mine was photographed and destroyed to allow the clearance operation to continue.

[Photo clearly showing mines found inside the perimeter marked by old marking.]
