DDAS Accident Report

Report date: 08/07/2011	Accident number: 720
Accident time: 10:29	Accident Date: 21/03/2011
Where it occurred: Sabha 11/(384), Kum Al Ruff Village, Mafrq Province, Sector East	Country: Jordan
Primary cause: Field control inadequacy (?)	Secondary cause: Unavoidable (?)
Class: Excavation accident	Date of main report: None
ID original source: None	Name of source: Demining group
Organisation: [Name removed]	
Mine/device: M14 AP blast	Ground condition: dry/dusty grass/grazing area rocks/stones
Date record created:	Date last modified: 08/07/2011
No of victims: 1	No of documents: 2

Incident investigation for [Demining group] – Mine Action Team – Jordan

Task Name: Sabha 11/ (384)

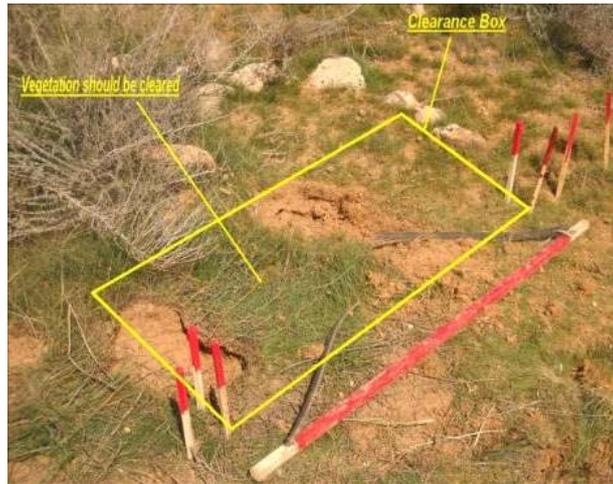
The deminer was working in IOE containing M14 AP mines in Section 3 in Sabha 11, he used the MD to indicate the location of the mine then used the light rake then excavated using the heavy rake, during the excavation for the mine using the heavy rake, the deminer hit accidentally the AP mine on the top which detonated the mine.

The accident site

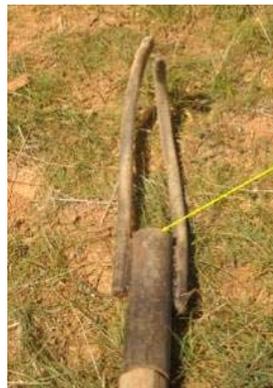
13. List any mine action equipment or property damage: Heavy Rake, Damaged (Not Reusable)

The damaged Heavy rake
