DDAS Accident Report

BAC INCIDENT REPORT 013/07

Report on Incident that occurred on the 20th August 2007 at CBU 855, Area 1, Al Hinnieh

The Incident occurred in Area 1 (CBU 855), UTM 706470-3673983 on the 20 August 2007, on a Completed Site where one M77 Sub-Munition was located inside an orchard.

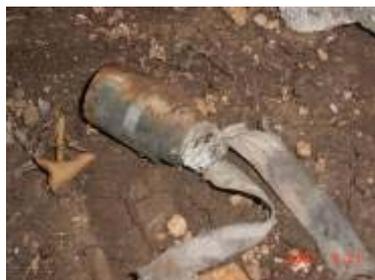
[The M77]

The sub munition was a M77, intact and showed traces of rust on the outer casing

The M77 was located on top of the surface.

The local worker stated the M77 was found in July 2007 subsurface. The orchard has been watered since the findings and now found the second time subsurface.

The location of the sub-munitions was identified as in an area that surface clearance had taken place.

The primary cause of this incident is listed as *Inadequate survey* because the area had been tasked for a superficial surface (visual) clearance when at least one submunition had gone subsurface. The secondary cause is listed as a *Management control inadequacy* because the report makes no recommendation that the MACC SL who allocated the Task should correct their survey error after finding that it was inappropriate. It is remarkable that the report makes no recommendations for a secondary, subsurface clearance of an area where a device had been located subsurface. It is also strange that the investigator decided that the area was safe to enter and continue a visual Quality Assurance check when fully aware that sensitive items might be below the surface. The apparent irresponsibility of the management group is unusual. Because the investigation was carried out by the organization that made the errors, this incident is listed under Notes as having had "No independent investigation".

The BACTEC EOD team will be called out remove or destroy the M77.

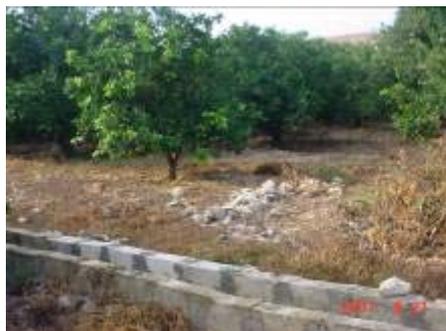
6. On arrival at the incident site, it was ascertained that there is safe access from the control point to the incident site without additional clearance being conducted.

[The site]
