DDAS Accident Report

Report date: 09/07/2011	Accident number: 731
Accident time: 10:28	Accident Date: 17/04/2011
Where it occurred: Task No: Sabha 10/ (385), Kum Al Ruff Village, Mafraq Province, East Sector.	Country: Jordan
Primary cause: Unavoidable (?)	Secondary cause: Unavoidable (?)
Class: Excavation accident	Date of main report: None
ID original source: None	Name of source: Demining group
Organisation: [Name removed]	
Mine/device: M14 AP blast	Ground condition: hard rocks/stones
Date record created:	Date last modified: 09/07/2011
No of victims: 2	No of documents: 2

Incident investigation For [Demining group] Mine Action Team, Jordan

Task Name: Sabha 10 (385)

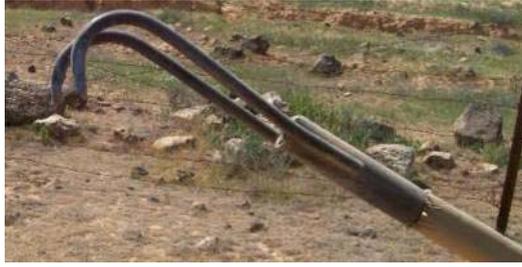
13. List any mine action equipment or property damage: Heavy Rake, Damaged (Not Reusable)

Damaged Heavy rake

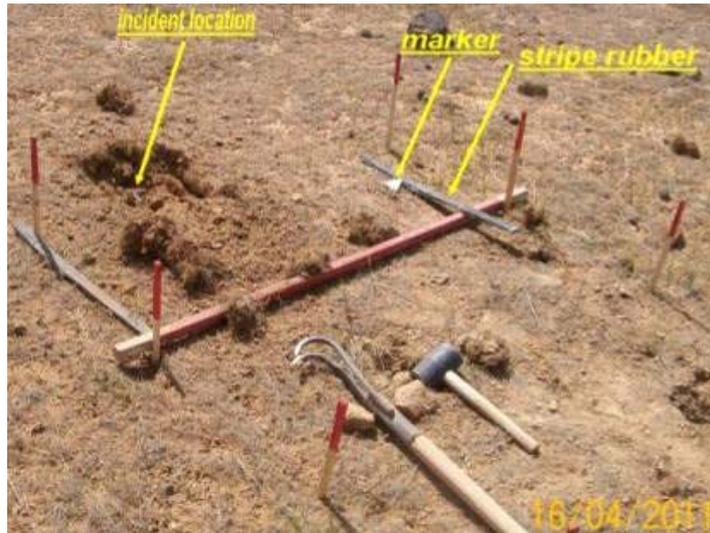
17. Comments (include measurements of any crater resulting from the explosion): Crater Depth: approx. 10 cm / Width: approx. 26 cm

Ground/Terrain: Flat, Hard, Open

Accident site
