# DDAS Accident Report

**RE: INVESTIGATION OF BLU 63 FOUND ON CBU 362 ON 14 JUNE '07**

**Internal Investigation and Follow up Action - CBU 362**

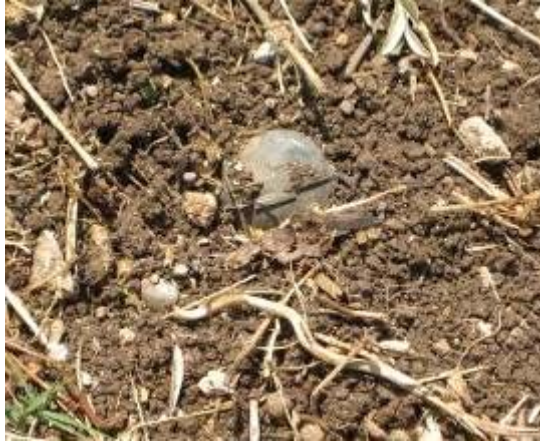
The BLU 63 located was partially buried with about one third protruding from the surface.

[The BLU63 in situ]

Because the area was recently worked on (ploughed) and thus the lack of evidence, it cannot be confirmed that the BLU 63 was missed during clearance, its original depth or previous location and possible migration / importation with the compost.

The area had been originally searched using the Schonstedt locator. This is a stick-detector designed for locating ferrous pipelines. Its limited search area and capabilities mean that its use for area clearance is questionable, but was approved by the UN MACC SL despite misgivings. After the device was found, the demining group made a visual search of the area 25 metres around it. If it were missed in the original detector search, correcting the error with a limited visual search was clearly inadequate.

[Name removed] and his EOD team was instructed to do a visual surface search of the area (25m x 25m box) surrounding the BLU 63.

No further BLU 63 were located within this area. The BLU 63 was destroyed in situ.
