DDAS Accident Report

Report date: 19/07/2011	Accident number: 741
Accident time: 10:40	Accident Date: 12/11/2007
Where it occurred: EOD-12, Kolalan Village, Anaba District, Panjshir Province	Country: Afghanistan
Primary cause: Field control inadequacy (?)	Secondary cause: Inadequate training (?)
Class: Handling accident	Date of main report: 15/11/2007
ID original source: (35)	Name of source: UNMACCA and Demining group
Organisation: [Name removed]	
Mine/device: Fuzes (PD 120 mm/100)	Ground condition: not recorded
Date record created:	Date last modified: 19/07/2011
No of victims: 2	No of documents: 1

INTERNAL INVESTIGATION REPORT [Demining group], KABUL November 2007

LESSONS LEARNED SUMMARY OF DEMINING ACCIDENT OCCURRED TO [Demining group] EOD-12 ON 12 NOVEMBER 2007

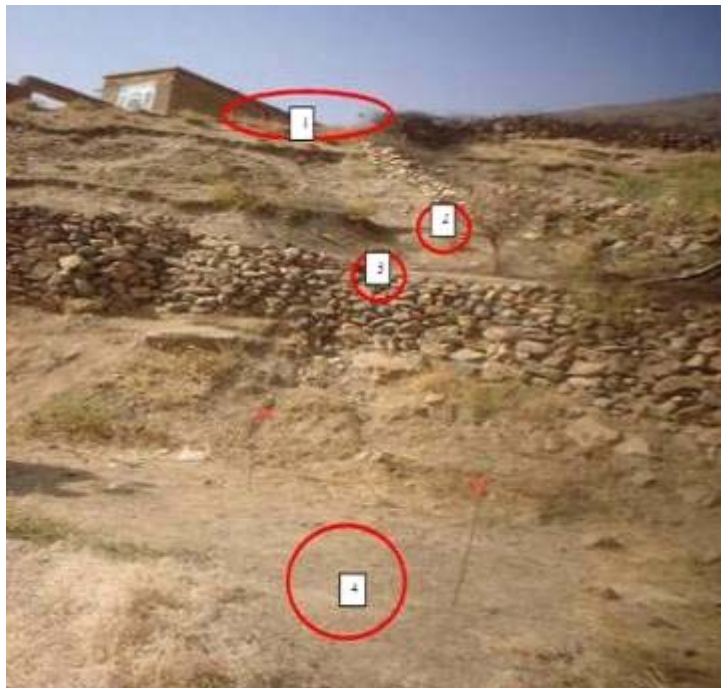
[The accident site]

On 12 November 2007 Section No. 1 started its normal work and identified a PD fuse at Location 2 shown in the picture below.

[The Victims] - operators of EOD 12 - were following the MCT section for categorisation of marked UXO. The PD fuse located at Location 2 was categorized as safe and [Victim No.2] handled it from Location 2 onto the rock wall between himself and [Victim No.1] who was situated at Location 4. [Victim No.1] was to retrieve the PD fuse from the wall and move it to field UXO Collection Point. The PD fuse has fallen from the wall to the ground and detonated, resulting in the two casualties.

BAC searching line location during accident - 1

Marked UXO by BAC Section - 2

Handling of UXO by [the Victims] - 3

Accident point and [Victim No.1] location - 4

- The accident occurred during a BAC task.
- The accident occurred during the handling process from one operator to another over uneven terrain
- The operator was handling the fuse and giving it to another operator because of the natural barrier (rock wall) between them.
- The box has fallen to the ground and resulted in the detonation of the fuse.
- The Section Leader of EOD 12 was 60m away from the point of detonation.
