DDAS Accident Report 743

Report date: 05/04/2019	Accident number: 743
Accident time: 07:40	Accident Date: 11/10/2007
Where it occurred: Bint Jbeil, Kunin, Area 3.	Country: Lebanon
Primary cause: Victim inattention (?)	Secondary cause: Other (?)
Class: Handling accident	Date of main report: 16/12/2009
ID original source: None	Name of source: Press/other
Organisation: [Name removed]	Ground condition: hard, rocks/stones, steep slope
Mine/device: M77 submunition	Date last modified: 05/04/2019
Date record created:	No of documents: 1
No of victims: 1

Lebanon blast death of bomb expert

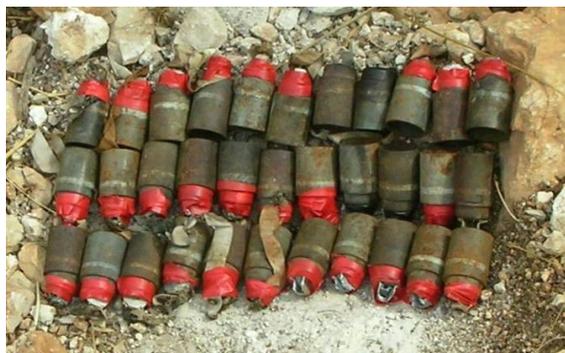
The separate demining/EOD team sent to make the area safe after the accident found 33 M7 submunitions, shown after being collected together below.

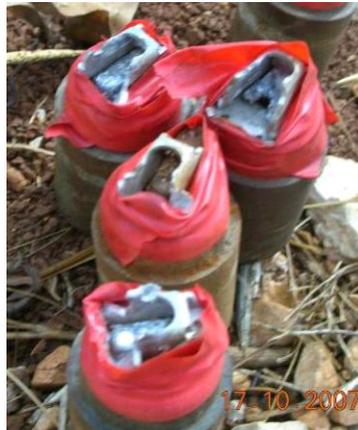
It is normal for these munitions to be 'gagged' by having the slide which blocks the firing pin held in place by wrapping strong adhesive tape around the fuze assembly. It is not normal to then break away the metal housing to remove the firing pin, but in this case that had been done.

Considerable force was needed to shear the metal but the result may have been thought technically 'safer' than simply 'gagging' the slide bar. Gagging prevents the pin falling onto the sensitive detonator but the pin is still there. By breaking the housing and removing the pin, there is less risk of an accidental detonation if the 'gagging' should fail.

However, the person leading the second demining/EOD team reported that gagging with several wraps does not fail so the intervention was unnecessary, and that the victim had died while doing something that he believed was inherently unsafe.

The primary cause of this accident is listed as *Victim inattention* because it seems that the Victim was trying to remove the firing pin from an M77, which is not generally accepted as a necessary risk to take. When the device must be moved, the norm is to render it safe by winding a “gag” over the arming slide to prevent it sliding out (using adhesive tape) before moving it. If the device has armed, the convention is to destroy it where it is.

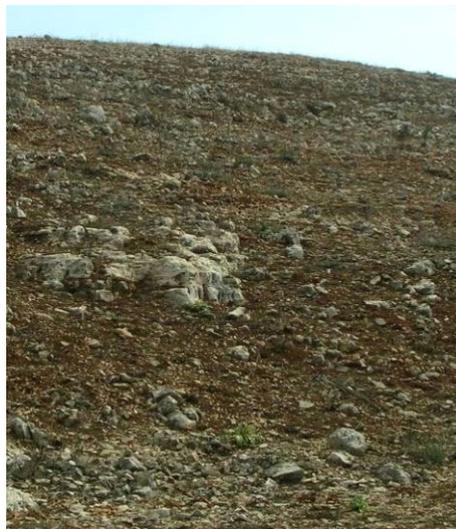
The second team also photographed the area of the accident, showing a rocky hillside with little vegetation.
