DDAS Accident Report

Report date: 11/07/2011	Accident number: 745
Accident time: 07:40	Accident Date: 11/07/2007
Where it occurred: CBU 203, See map coordinates	Country: Lebanon
Primary cause: Field control inadequacy (?)	Secondary cause: Field control inadequacy (?)
Class: Missed-mine accident	Date of main report: 11/07/2007
ID original source: None	Name of source: UN MACC SL
Organisation: [Name removed]	
Mine/device: M77 submunition	Ground condition: agricultural (recent) soft
Date record created:	Date last modified: 11/07/2011
No of victims: 0	No of documents: 1

LAF SAMPLING TEAM INVESTIGATION REPORT FOR [Demining group] BAC
SUBSURFACE CLEARED SITE AT TASK CBU- 203

Task: CBU- 203,

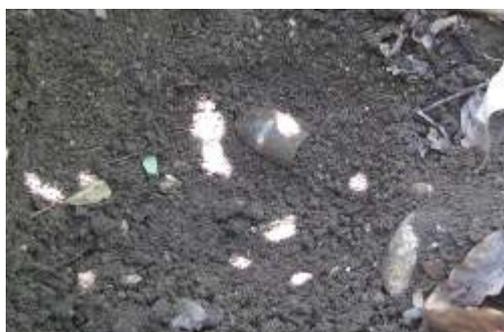
Sampling Team located submunition M77 on CBU 203 in cleared and completed area by [Demining group].

Item found in depth 5cm.

[M77 as found]

The primary and secondary cause of this accident are listed as *Field control inadequacy* because the demining group was clearing using Minelab metal detectors and apparently left significant metal behind, including at least one M77 submunition. The only explanation for so much metal being left is that the search was not conducted appropriately and parts of the Task area were not searched. This is the “Inadequate training” referenced under Notes.

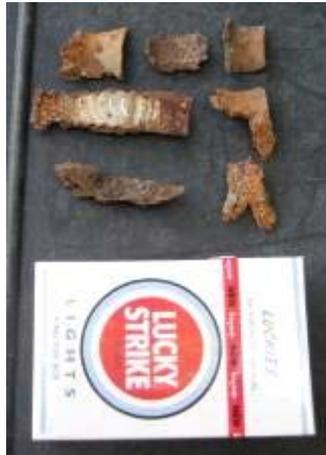
[Other photographs showed significant other amounts of metal found during the check. The demining group was clearing with metal-detectors so should have left cleared ground metal-free.]
