# DDAS Accident Report

### **Incident investigation for [Demining group] Mine Action Team, Jordan**

Task Name: Sabha 12 ( 383 )

### **IMSMA DETAILED REPORT FOR MINE INCIDENT, Monday , 11 April 2011**

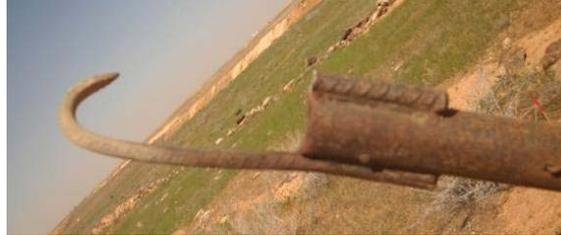
The deminer was working in SML D which contains M14 AP mines, he indicated the location of the mine then used the light rake then excavated using the heavy rake, during the excavation for the mine using the heavy rake the deminer accidentally caused a pressure on the AP mine pressure plate which caused the detonation.

13. List any mine action equipment or property damage: Heavy Rake, Damaged (Not Reusable)

The damaged Heavy rake

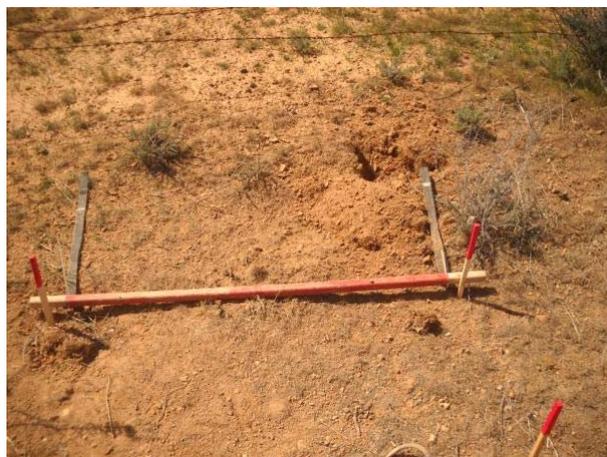
17. Comments (include measurements of any crater resulting from the explosion): Crater Depth: approx. 13 cm / Width: approx. 15 cm

Ground/Terrain: Flat, open

The accident site
