# DDAS Accident Report

**BAC INCIDENT REPORT 001/2007**

Report on Incident that occurred on the 19th Mar 2007 [actually 7<sup>th</sup>] at CBU 19, at Taibe.

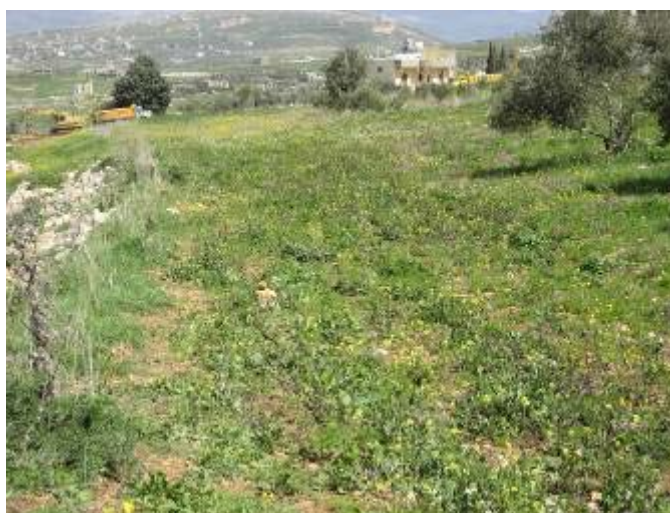
The ground is flat, comprising compact soil and covered in short vegetation. The M-77 submunition was surrounded on three sides by light vegetation and positioned on its side with approximately two thirds buried. The location of the submunition had been marked by [Demining group] with red spray paint (boundary), red sprayed rocks (to one side) and red / white danger area marking tape (boundary).

The large rock marks the location

[Demining group] have completed verification of the immediate area of the incident by clearing a 50m<sup>2</sup> box around the submunition using sub-surface BAC procedures. No items of ERW were located.

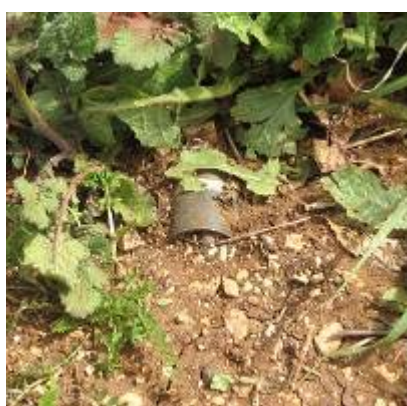
The M77 submunition

The submunition was positioned on its side, with approximately 2/3 buried, and was surrounded by light vegetation. According to [Name removed] (MACC CLO), the shepherd had removed some of the vegetation when he discovered it.

The submunition is considered as missed and should have been located by [Demining group] during the BAC operations.

[Demining group] shall conduct 1 day's refresher training for BAC Team 7 for surface BAC procedures prior to commencing operations.

[Demining group] Project Manager has submitted an amendment to their BAC SOP pertaining to visual / instrument assisted surface clearance. This procedure shall take immediate effect and the SOP shall be reviewed by the MACC SL.
