# DDAS Accident Report

<b>Report date:</b> 15/07/2011	<b>Accident number:</b> 761
<b>Accident time:</b> Not recorded	<b>Accident Date:</b> 06/06/2007
<b>Where it occurred:</b> DA 483, See GPS coordinates	<b>Country:</b> Lebanon
<b>Primary cause:</b> Other (?)	<b>Secondary cause:</b> Other (?)
<b>Class:</b> Missed-mine accident	<b>Date of main report:</b> 06/06/2007
<b>ID original source:</b> None	<b>Name of source:</b> UN MACC SL
<b>Organisation:</b> [Name removed]	
<b>Mine/device:</b> M77 submunition	<b>Ground condition:</b> rocks/stones route (verge)
<b>Date record created:</b>	<b>Date last modified:</b> 15/07/2011
<b>No of victims:</b> 0	<b>No of documents:</b> 1

**Re: One M77 Sub munitions found in DA 483 by [Demining group] completed task.**

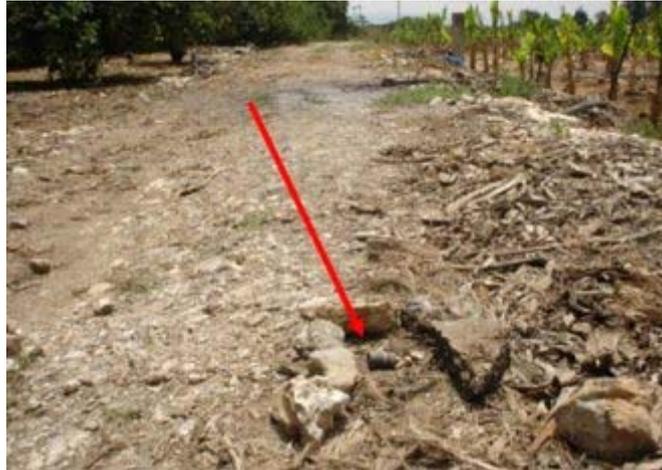
The item (M 77) was located on a road inside and between cleared areas. The road itself has been cleared and the item is so obvious that it cant been missed during clearance. See photo attached for road condition.

Red arrow points at M77 found. The road is a hard gravel road.
